City of New Ulm Downtown Preservation Design Guidelines

Prepared for
The New Ulm Heritage Preservation Commission

Prepared by Thomas R. Zahn & Associates
Spring 2018

CITY OF NEW ULM DOWNTOWN PRESERVATION DESIGN GUIDELINES

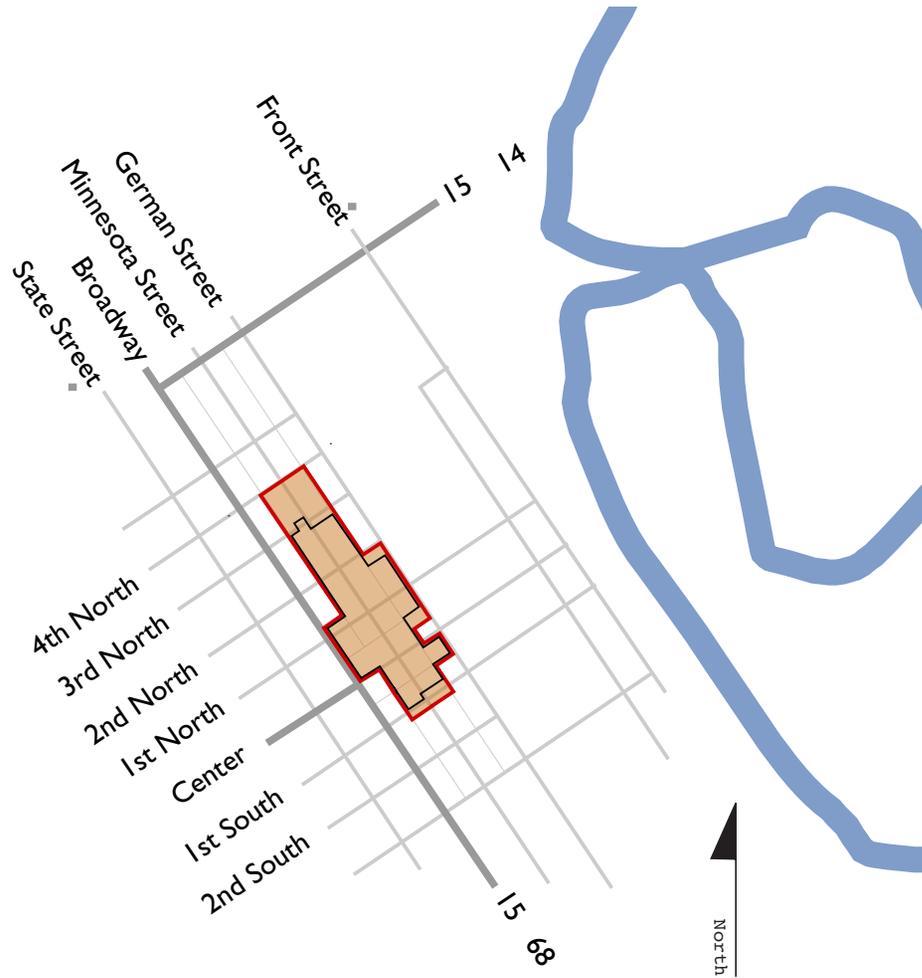
- National Register New Ulm Commercial Historic District Boundaries
- New Ulm Commercial Local Historic District Boundaries

The New Ulm Commercial Historic District is comprised of seventy-five properties, located primarily along Minnesota Street between 3rd North and 1st South. Within the National Register District there are sixty buildings that contribute to the historic fabric of the district.

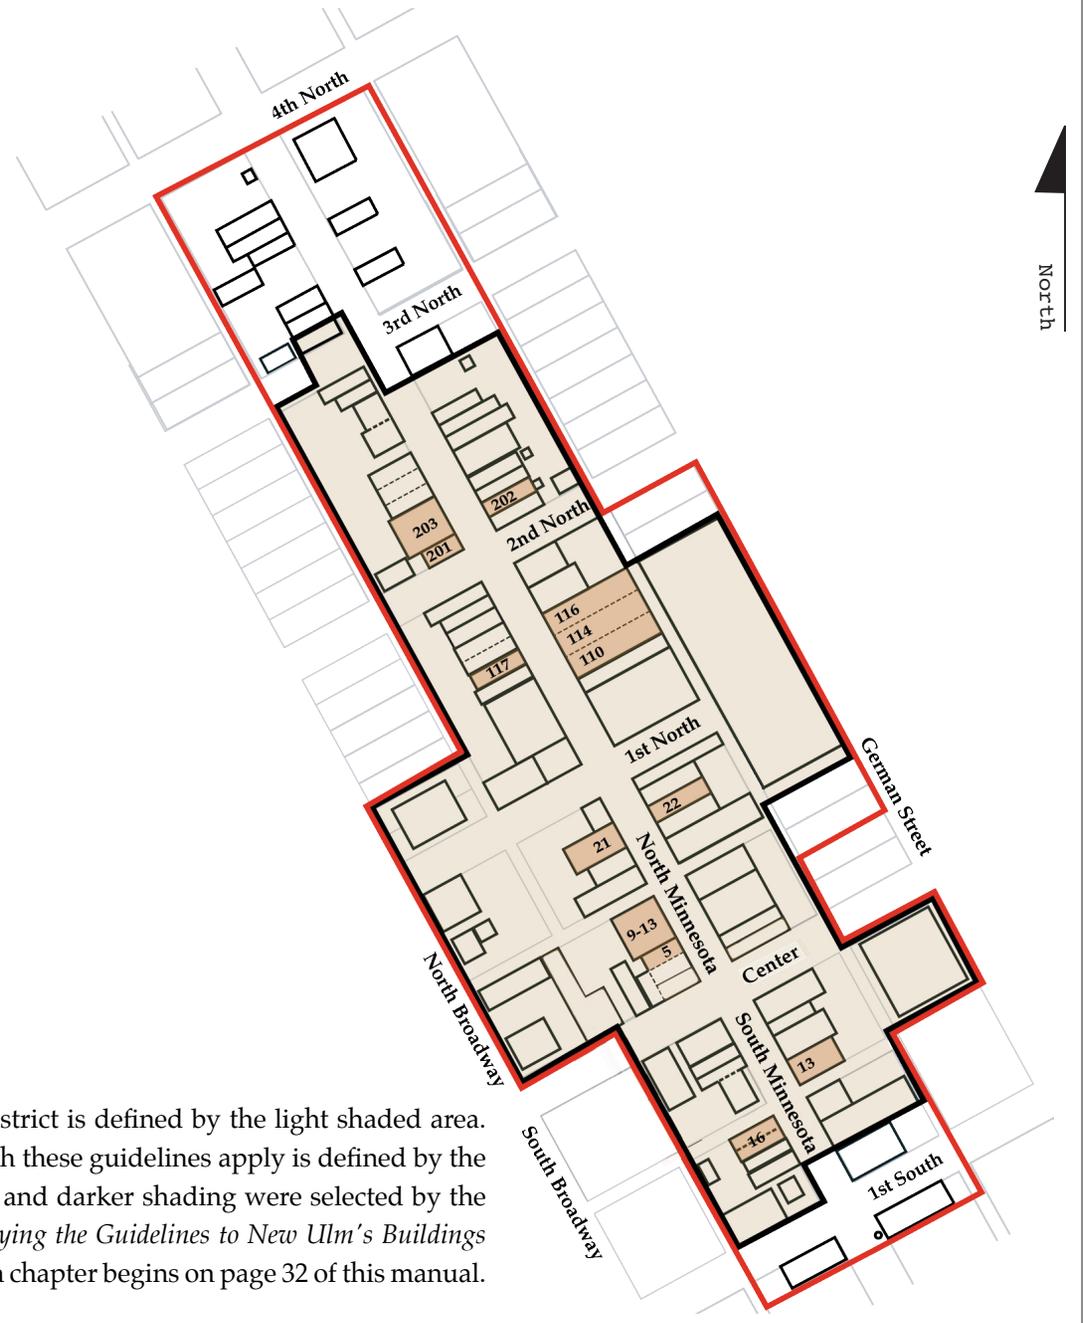
The National Register New Ulm Commercial Historic District is defined by the light shaded area. The local New Ulm Commercial Historic District for which these guidelines apply is defined by the red outlined area. Those properties indicated by address and darker shading were selected by the Heritage Preservation Commission to appear in the *Applying the Guidelines to New Ulm's Buildings* chapter of this manual. The "before" and "after" renovation chapter begins on page 32 of this manual.

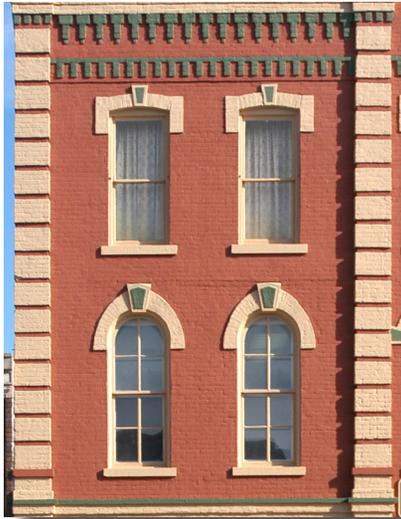
Italianate window detail on the Grand Hotel built in 1876

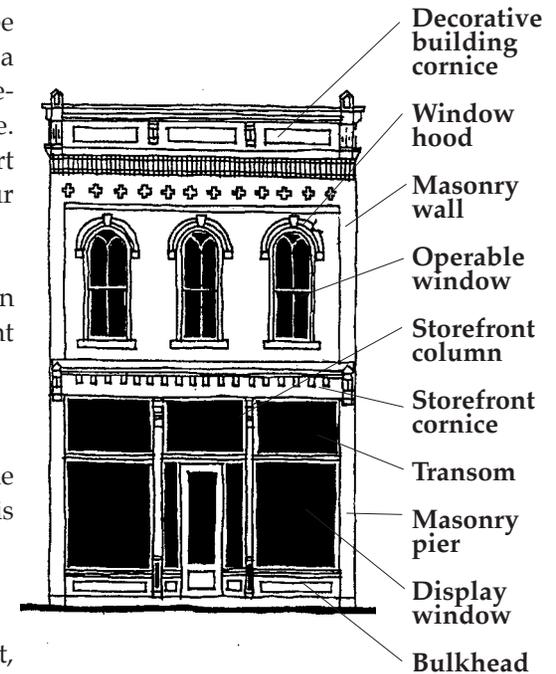
Inappropriate materials

The color and texture of the storefront materials should be simple and unobtrusive: (1) The storefront frame can be wood, cast iron, or aluminum with a baked enamel or appropriate colored anodized finish; (2) the display windows should be clear glass; (3) transom windows may be clear, prism, or stained glass; (4) the entrance door should have a large glass panel and can be made of wood, painted steel, or aluminum with a baked enamel or appropriate colored anodized finish; (5) the base panels (bulkheads) can be of wood, polished stone, glass, tile, or pre-finished or painted aluminum-clad plywood panels; (6) the storefront cornice can be made of wood, cast iron, or sheet metal, or appropriate prefabricated painted components, or sometimes the horizontal supporting beam can serve as the storefront cap; (7) the side piers should be of the same material as the upper facade.

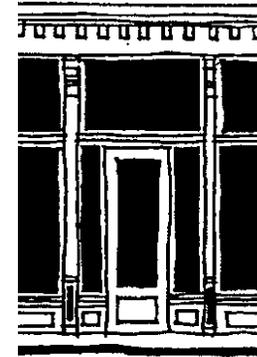
Original storefront doors were typically recessed, constructed of wood with a large window above a single or double panel that complemented the bulkhead design below the display windows

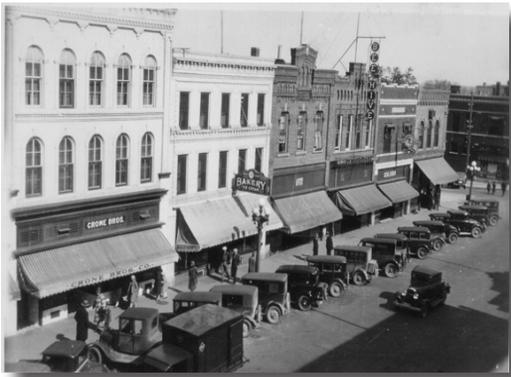
This early 20th-century photograph shows the extensive use of retractable canvas awnings in New Ulm's commercial district.

The application of appropriate new canvas awnings is encouraged.

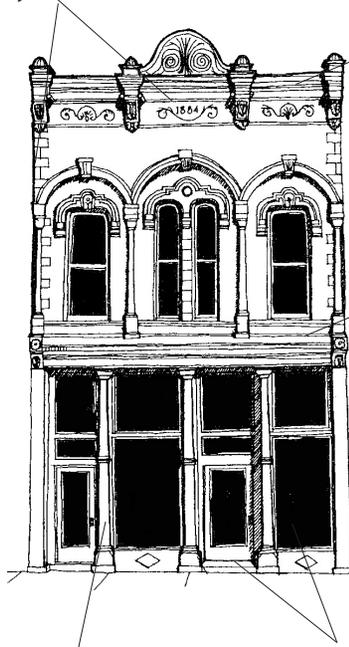
Building Cornice
Visually crowns the building

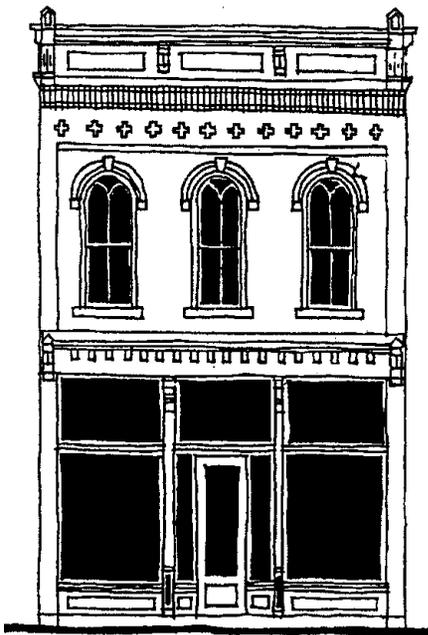
Paint Color Hierarchy

It is recommended that the elements of a building be painted to utilize colors consistent with an integrated design for all material and color choices of the entire exterior. Typically, trim elements that have the same function on the exterior receive same or similar colors: for example, all window and door frames are the same color, or cornices use the same or similar colors. The window sash and doors can be painted a darker color than the walls and trim. Do not paint masonry that is not painted. Prepare the surface to be painted by removing all loose paint and sanding all rough edges that remain. Prime the surface with a high quality oil-base primer and follow with two finish coats of oil-base or latex paint.

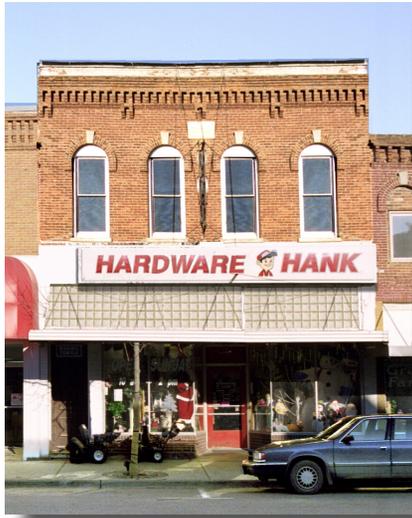
Backlit plastic signs and underlit awnings with lettering are inappropriate for historic buildings.

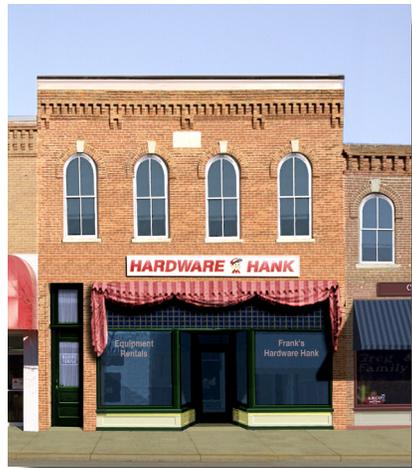
Flat signboards, low-profile projecting signs, painted lettering on the display windows and awning valance are appropriate.

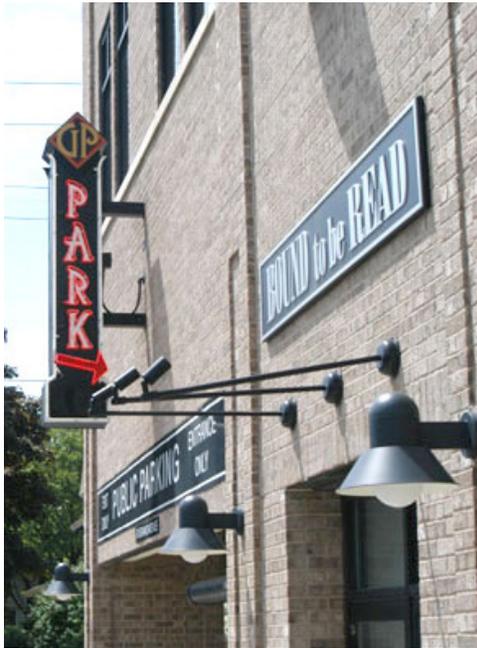
While lighting is generally discouraged, if applied on a well-designed, low-profile sign, it may be permitted.

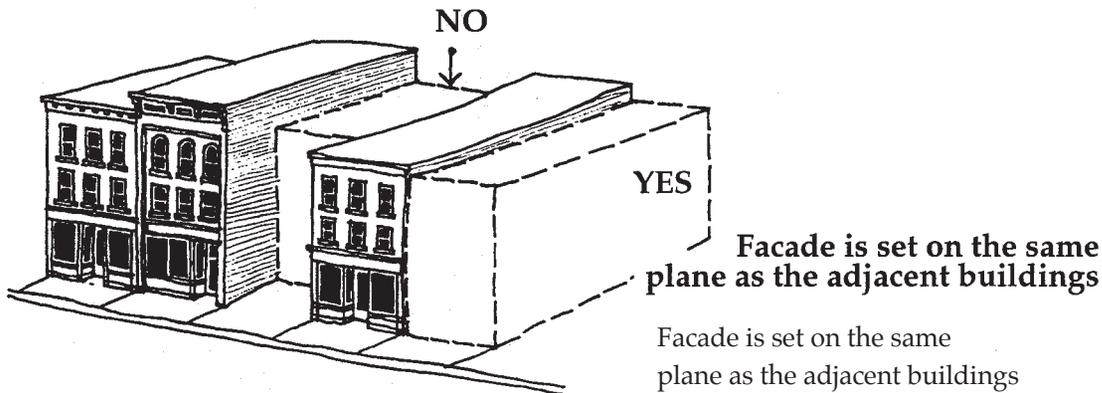
The new facade should be flush with its neighbors.

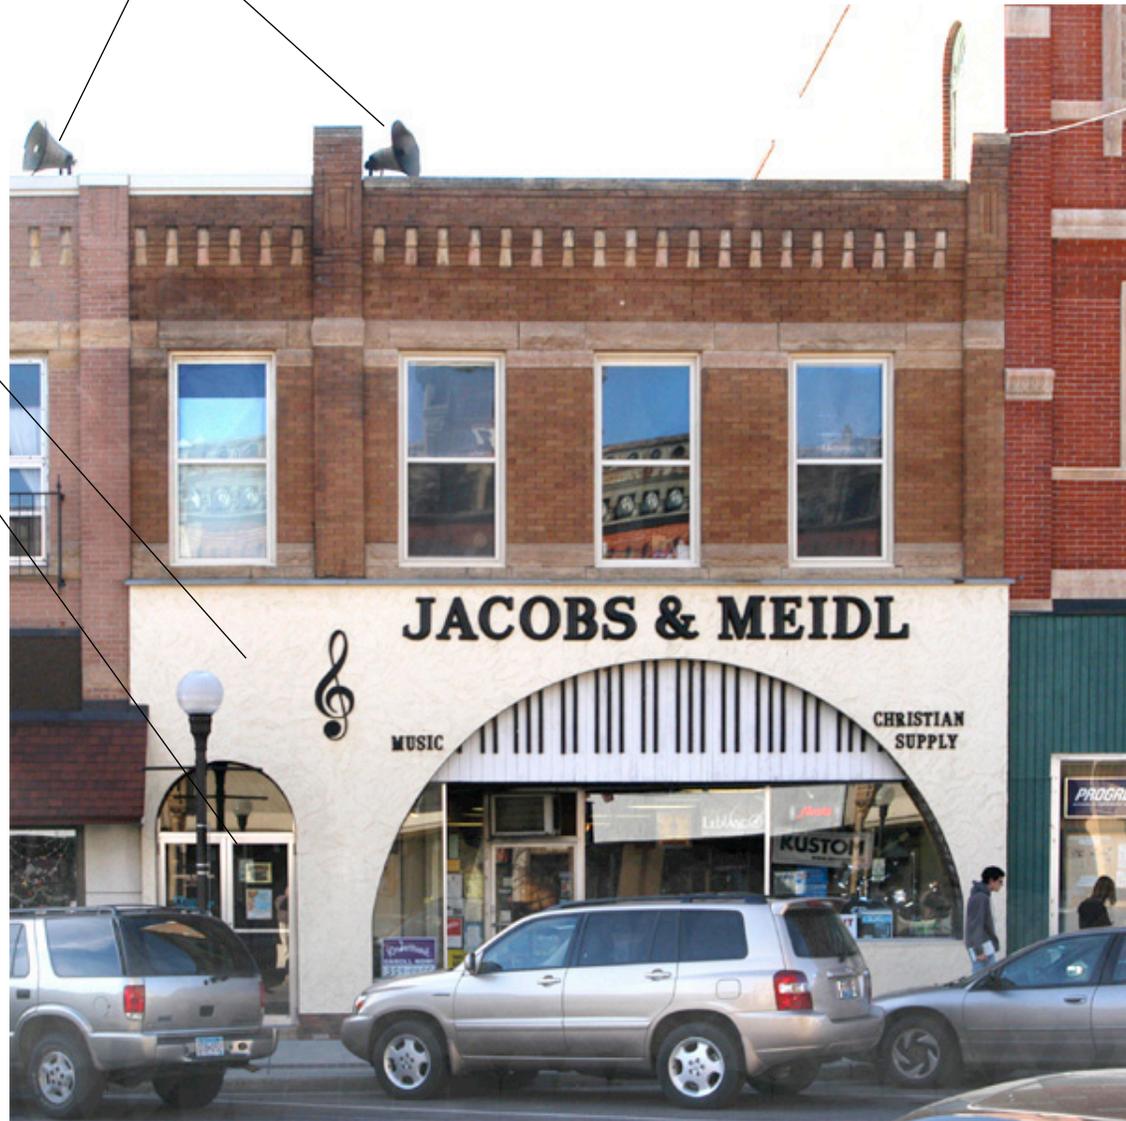
EXISTING CONDITION

Speakers, air-conditioners and other utilitarian hardware should not be visible to the pedestrian

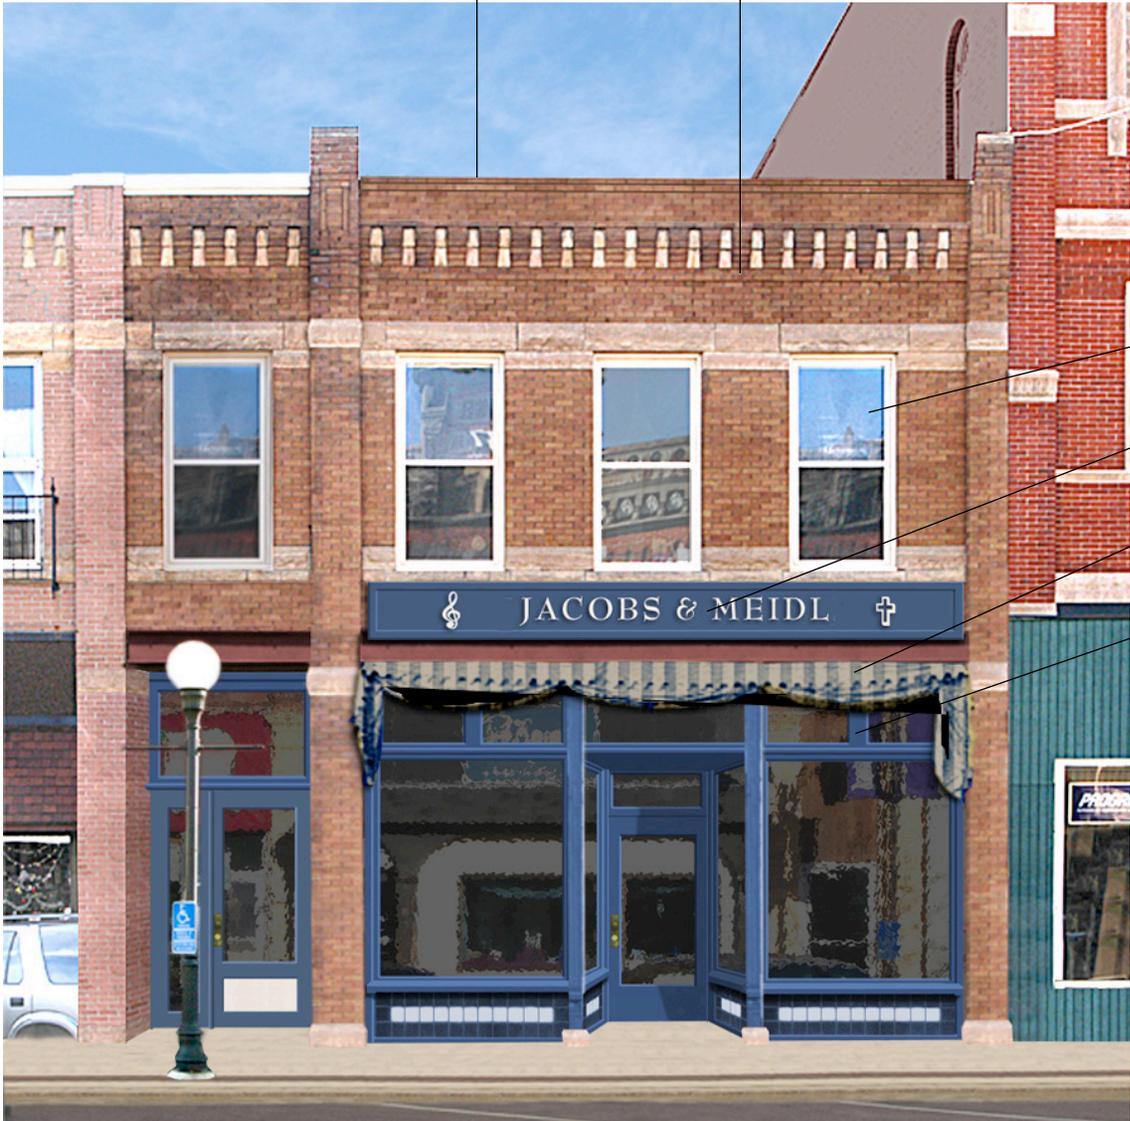
POTENTIAL RENOVATION

Repoint, repair and clean brick as necessary

Repair existing windows or replace with insulated double-hung windows

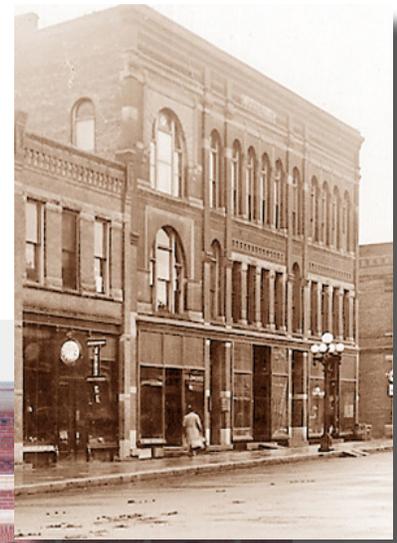
9-13 North Minnesota Street Masonic Block

Built in 1891, the three-story Masonic Block is a good example of a Romanesque Revival style brick building. While the upper stories retain their original openings, the third floor has had its windows infilled and the storefront level has been modified dramatically with three totally unrelated design treatments.

Repoint, repair and clean brick as necessary

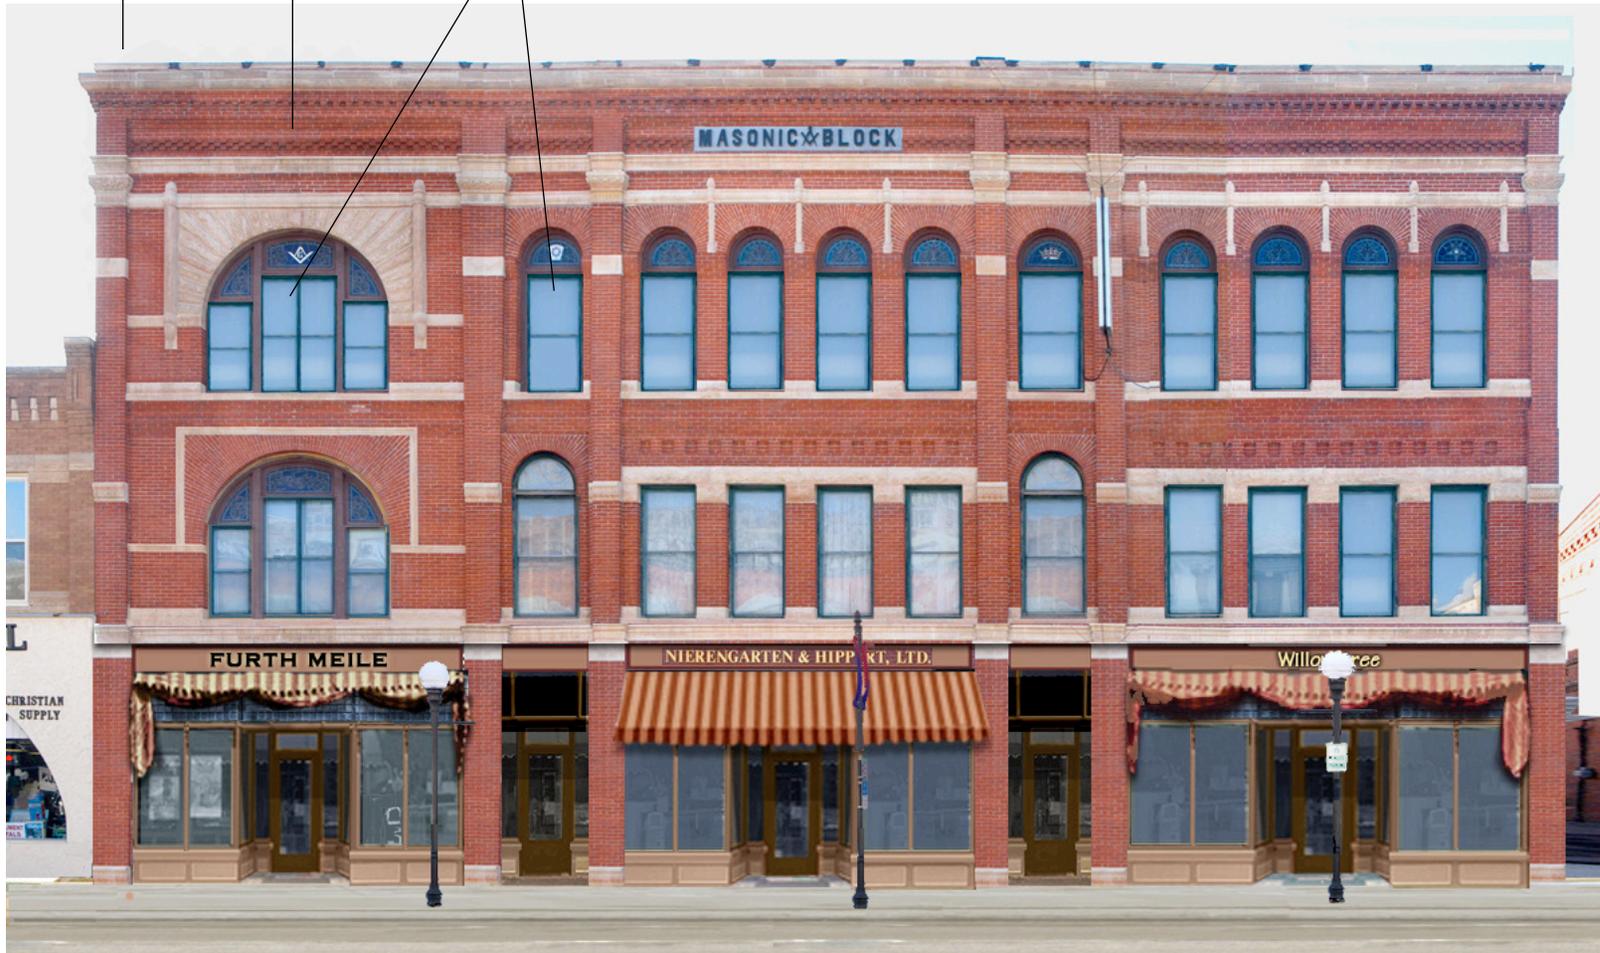
POTENTIAL RENOVATION

Return storefront to its original window/door relationship

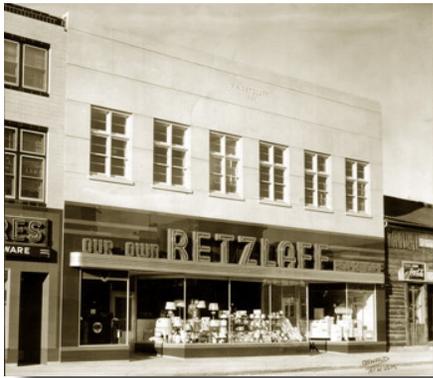
21 North Minnesota Street Retzlaff Hardware

This two-story stone commercial block retains much of its 1940 renovation. However, the inappropriate 'waterfall' awning detracts from and covers the building's original strong, "Moderne" architecture features.

Inappropriate "waterfall" awning extends across the entire main facade

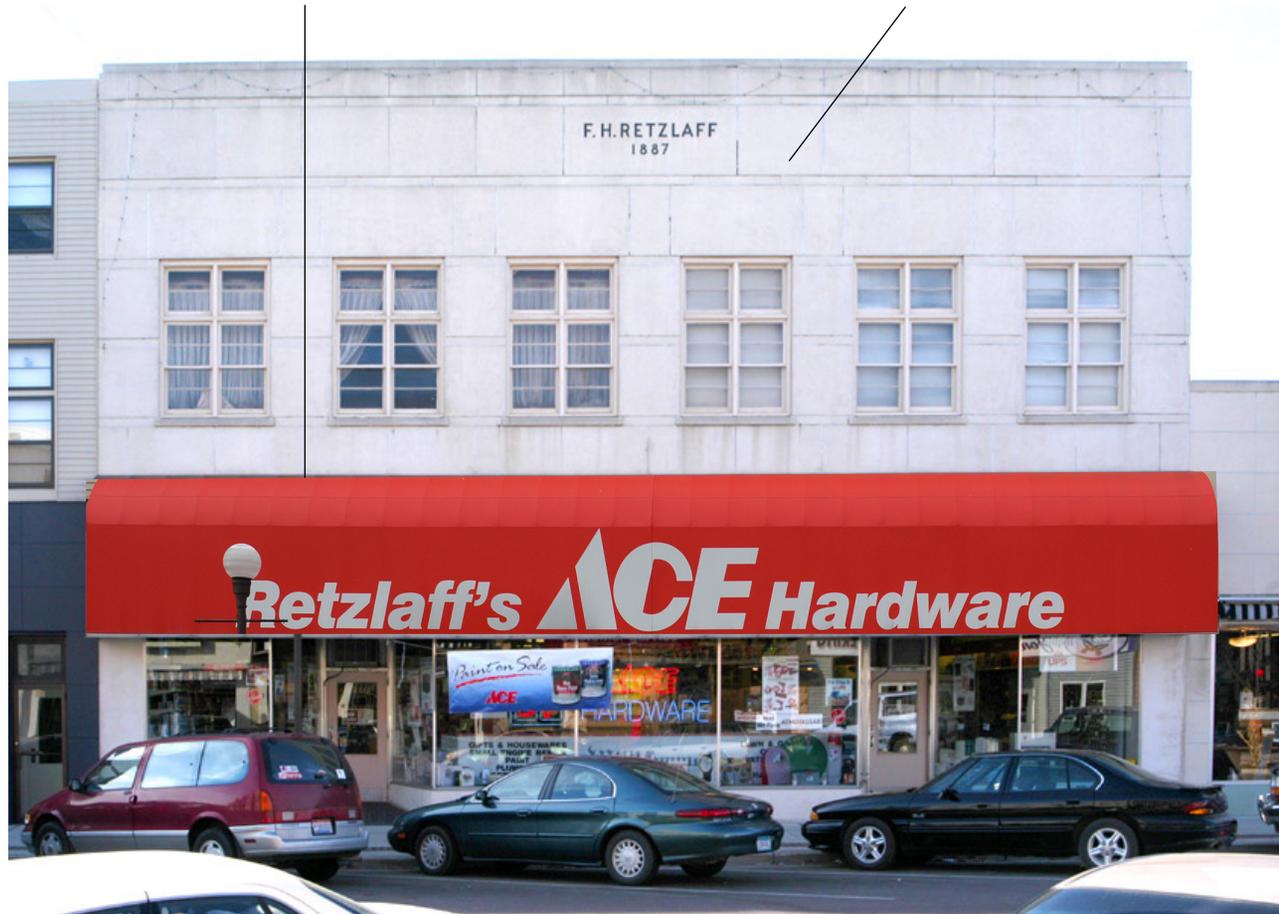
Artstone sheaths the upper story in the 1940's renovation of the two original buildings

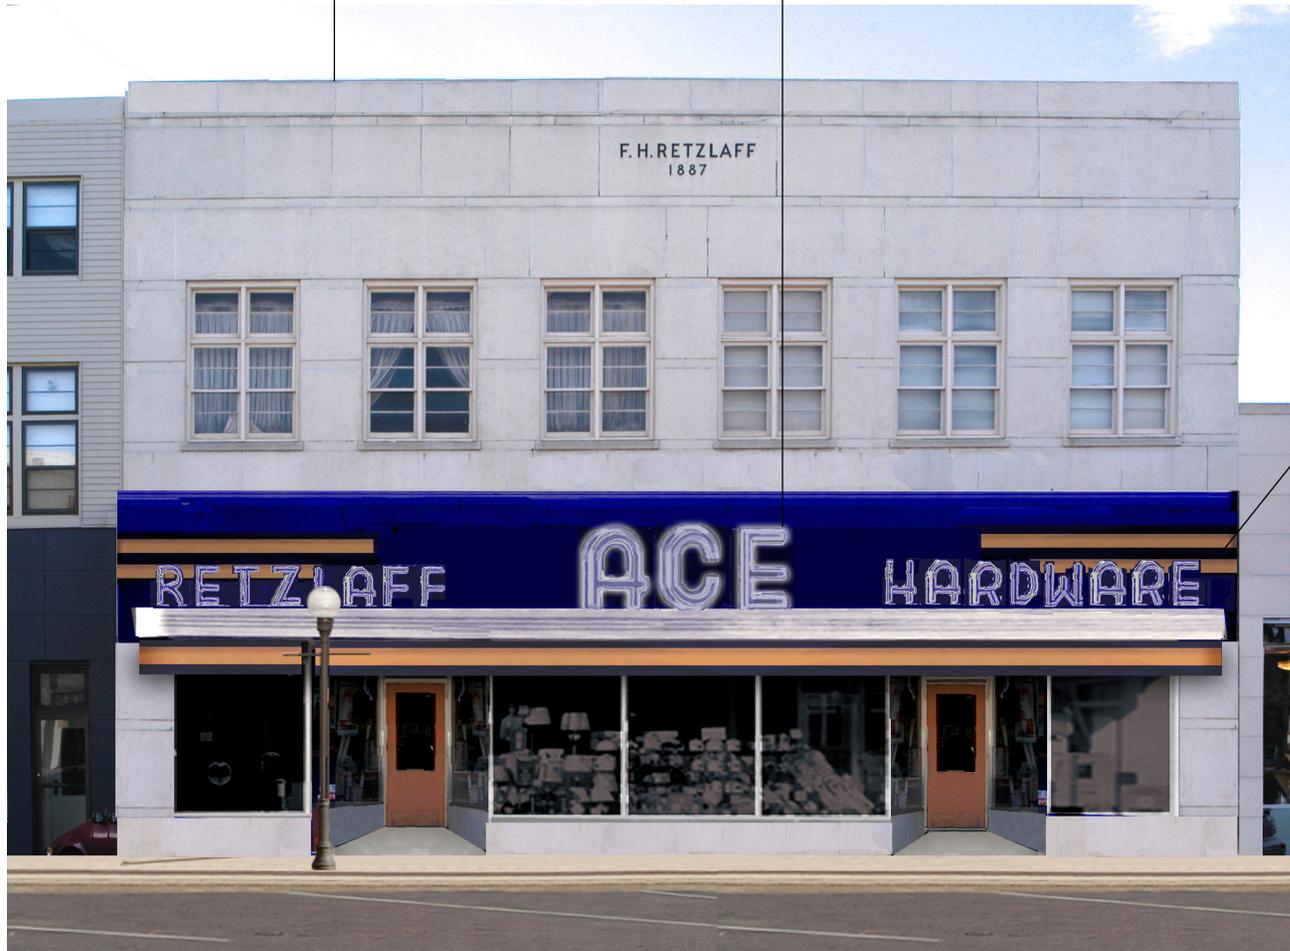
POTENTIAL RENOVATION

Replace and/or modify as-necessary and chrome signage on existing Art Moderne canopy

Clean and polish blue and orange "Vitrolite" that remains above the chrome-edged canopy

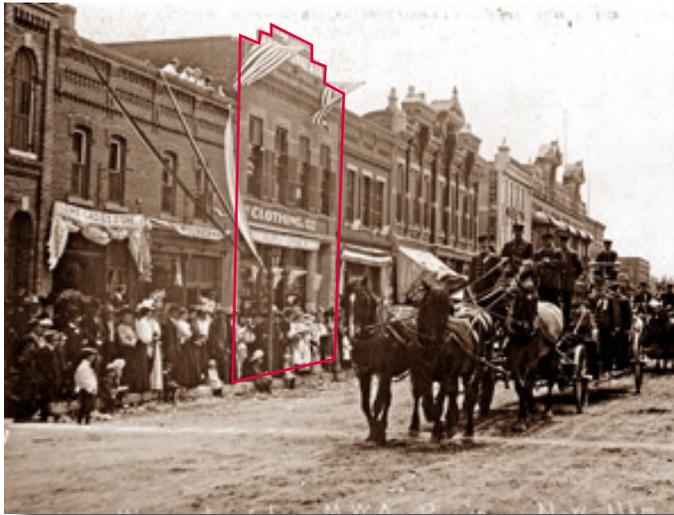
22 North Minnesota Street Gebser's Hall

The upper story retains its architectural integrity.

The "floating" sign does not fit the historic nature of the building or the downtown.

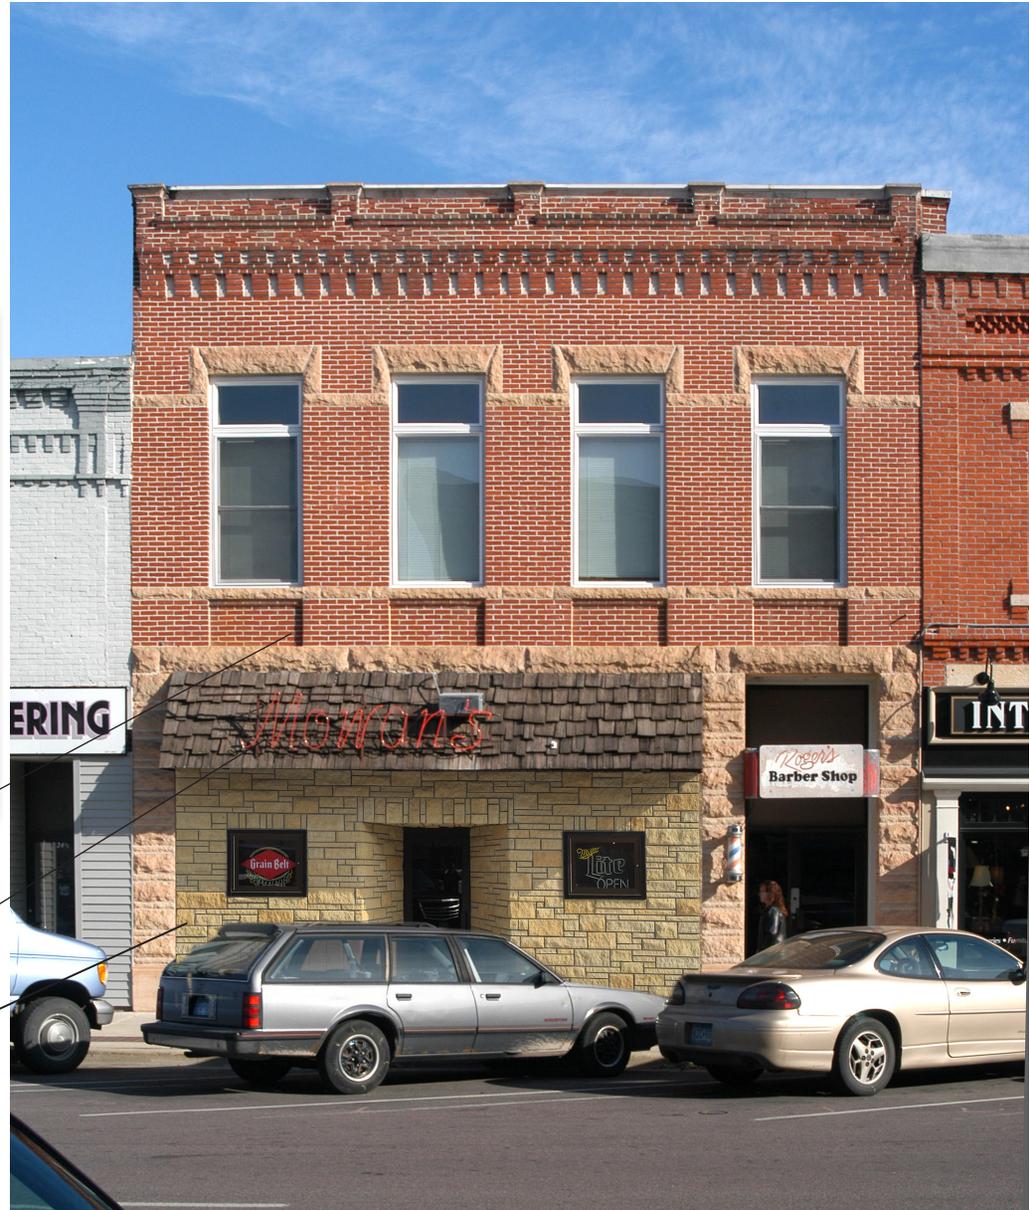
This building was constructed in 1894 with a saloon on the first floor and a meeting hall above. Groups that met here included the Unitarian Church (late 1800s), the Ladies of Germania Lodge and the Knights of Pythias (early 1900s).

The original storefront has been totally obscured with the use of inappropriate stone and a shingled shed canopy.

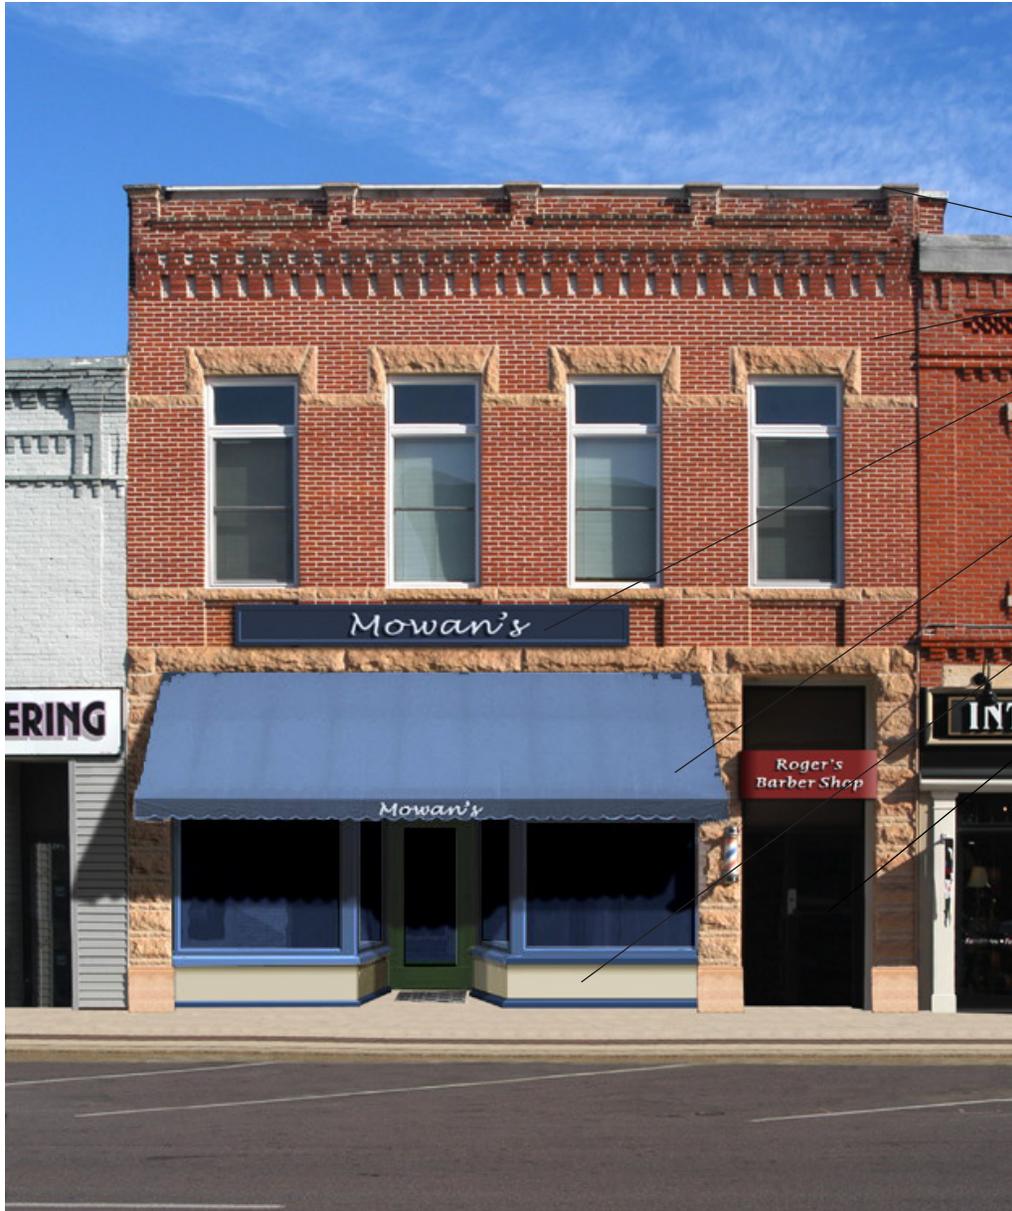
POTENTIAL RENOVATION

Inspect roofing and flashing.

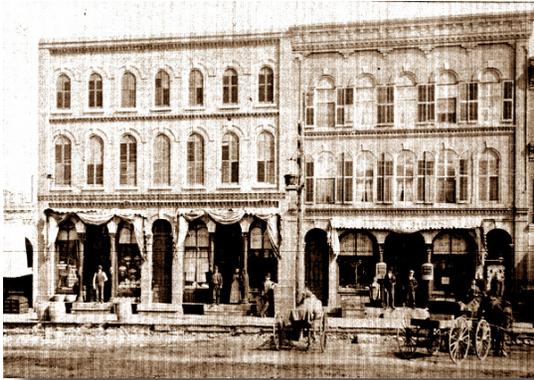
110 North Minnesota Street Crone Brothers Clothing

110 Crone Brothers Clothing—This three-story Italianate brick structure, built in 1869, once housed the largest retailer in New Ulm. The Crone Brothers building is the southern component of three buildings now owned by Herberger's department store.

112-114 Theodore Crone Dry Goods—Built ca. 1873, this three-story Italianate brick structure is the center of the three building blocks making up the present-day Herberger's complex. Like its neighbors to the south and north, the Theodore Crone Dry Goods building has been turned into a "painted lady" with inappropriate exterior paint application and colors.

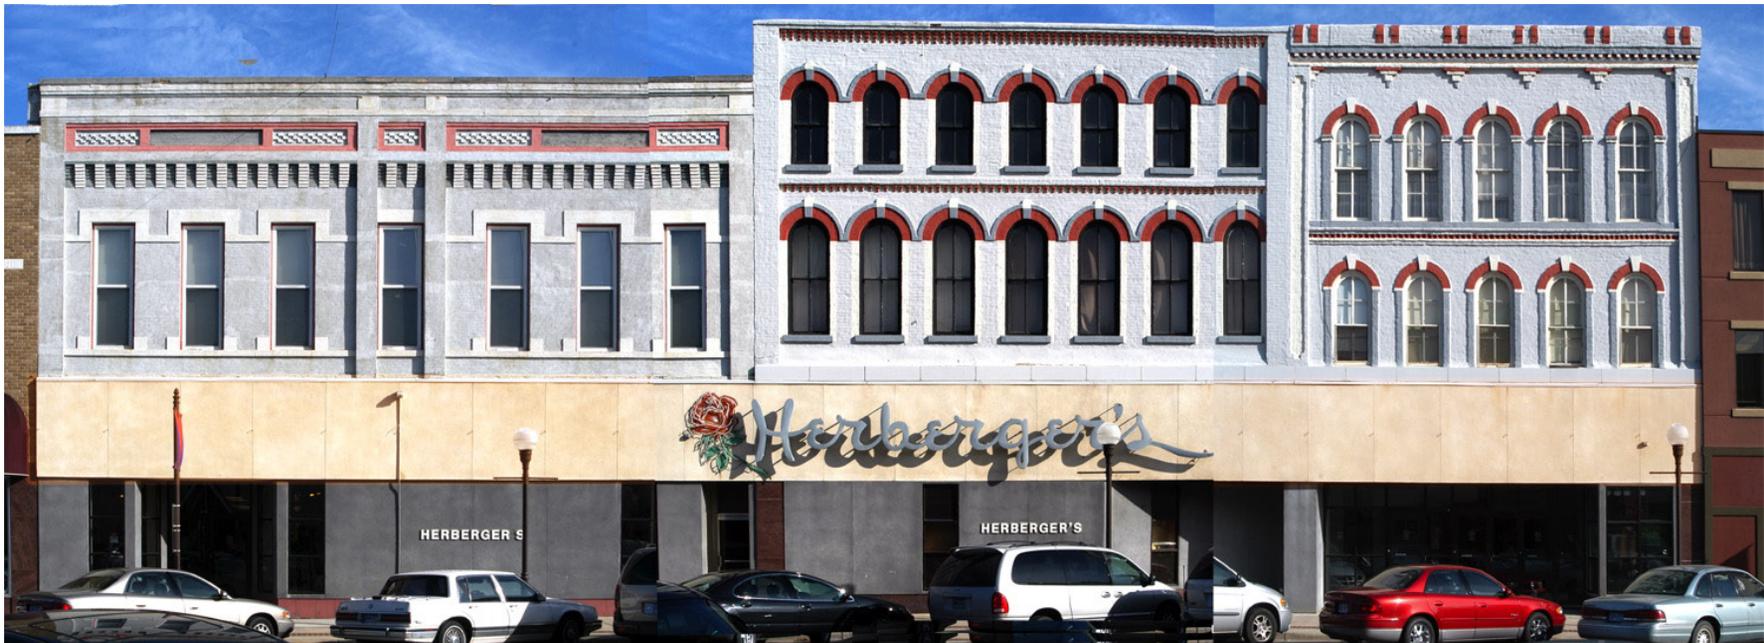
While the upper stories retain their original fenestration patterns, the elevations of the three separate blocks have been painted in a common color palette that deemphasizes their individuality. Similarly, the uniqueness of the three original storefronts has been replaced by a monolithic, commercial design treatment.

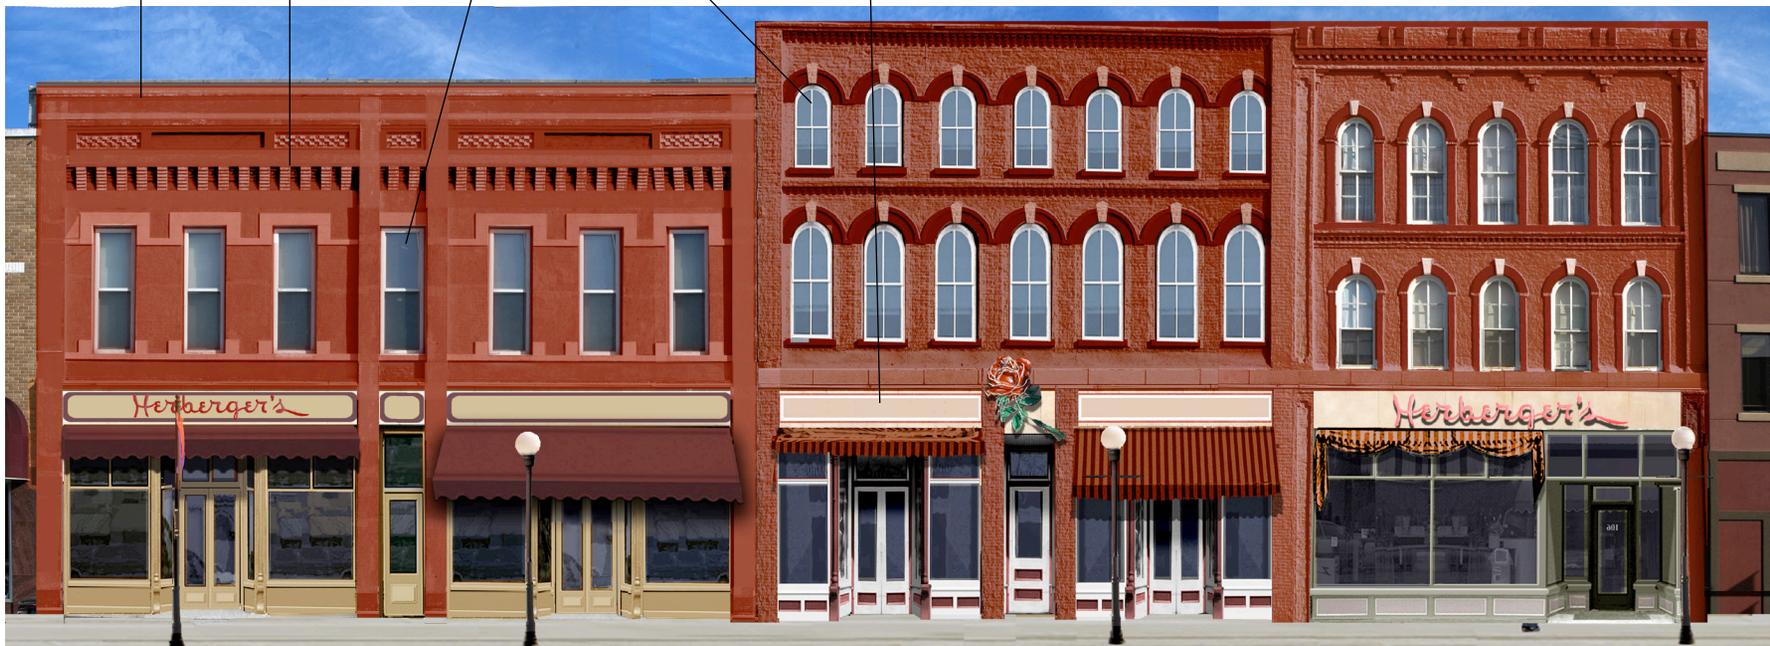
POTENTIAL RENOVATION

Return storefront to its original window/door relationship

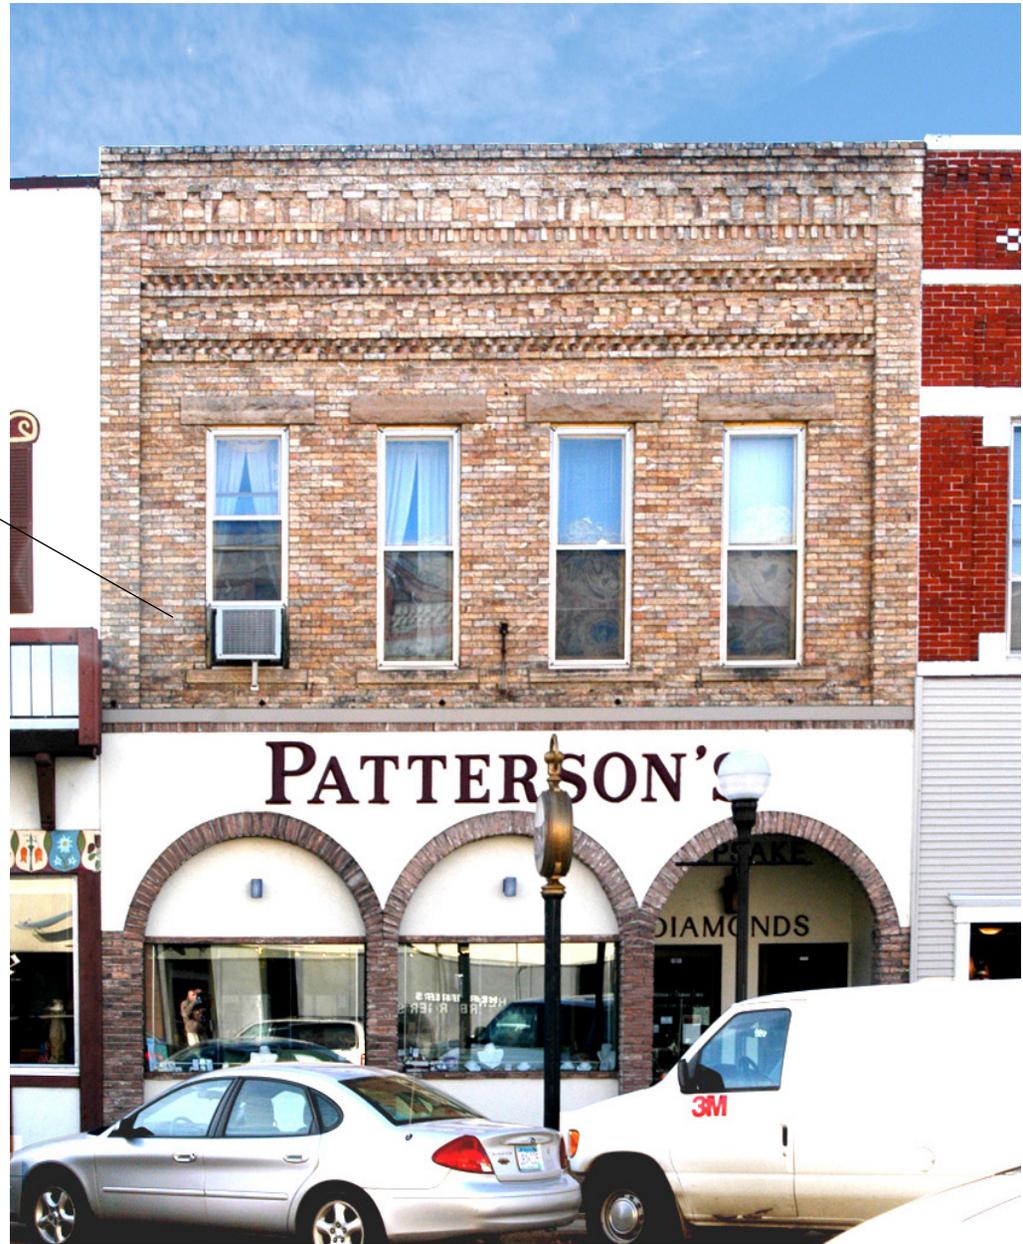
EXISTING CONDITION

While many of New Ulm's buildings originally had arcaded storefronts, this building had a simple, elegant rectilinear design. The present treatment hides the original beauty of this commercial building.

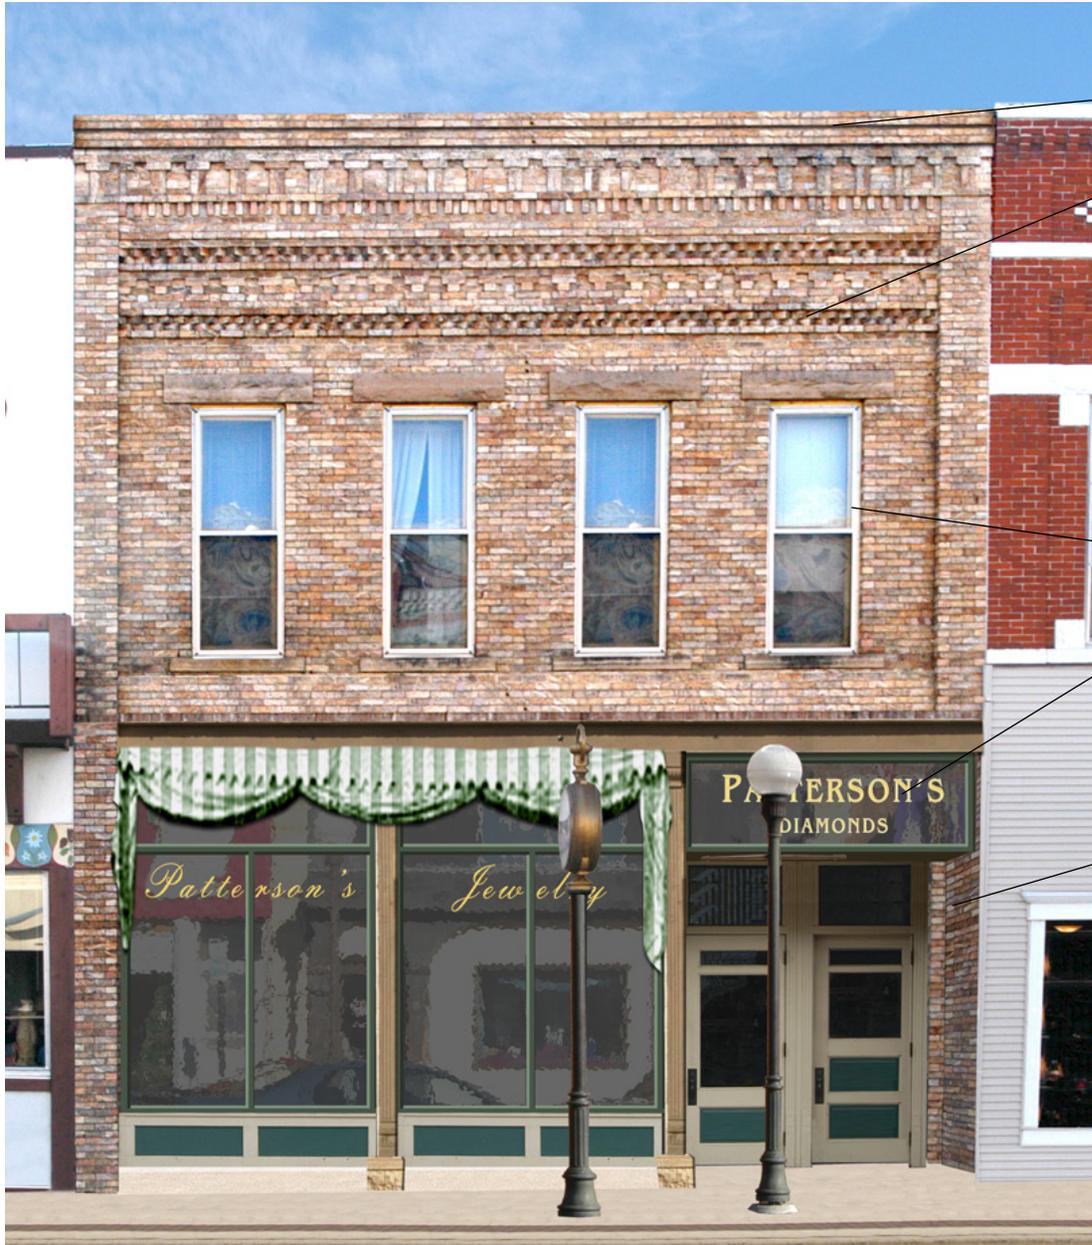
POTENTIAL RENOVATION

Inspect roofing and flashing

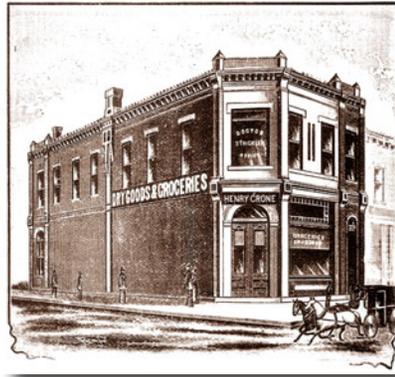
201 North Minnesota Street Doehne Block

Prominently located on a corner, this two-story brick commercial building retains most of its original upper story detailing. However, the first floor has been "modernized" with inappropriate materials and design elements. A newer element that improved the balance was a display window on the 2nd Avenue North facade.

Note that the chimney, partial parapets and finials have been removed from the cornice top.

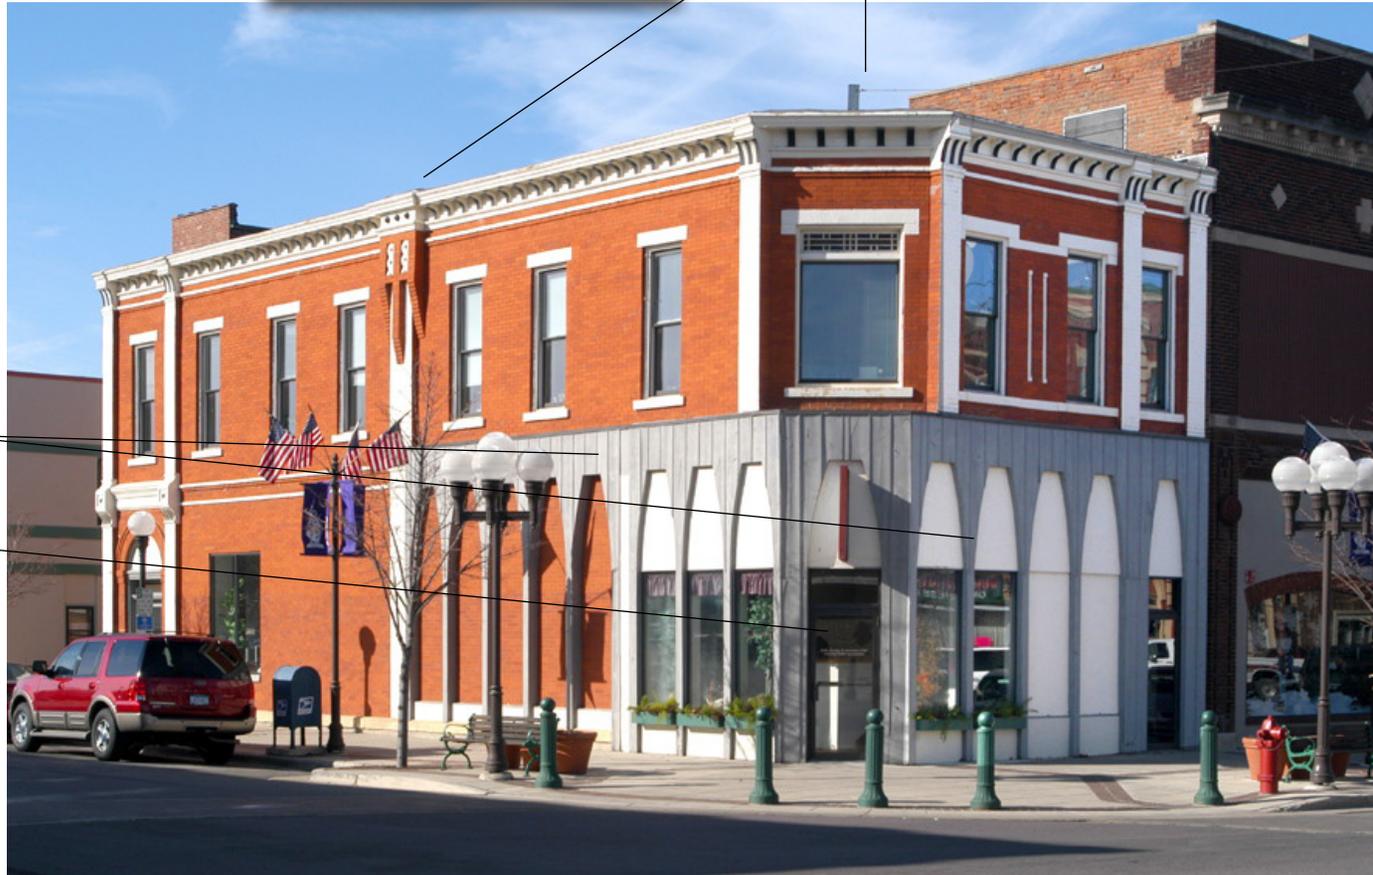
Modern vertical wood arches now obscure the original storefront and transom windows.
