City of New Ulm Downtown Preservation Design Guidelines

Prepared for
The New Ulm Heritage Preservation Commission

Prepared by Thomas R. Zahn & Associates
Spring 2018

CITY OF NEW ULM DOWNTOWN PRESERVATION DESIGN GUIDELINES

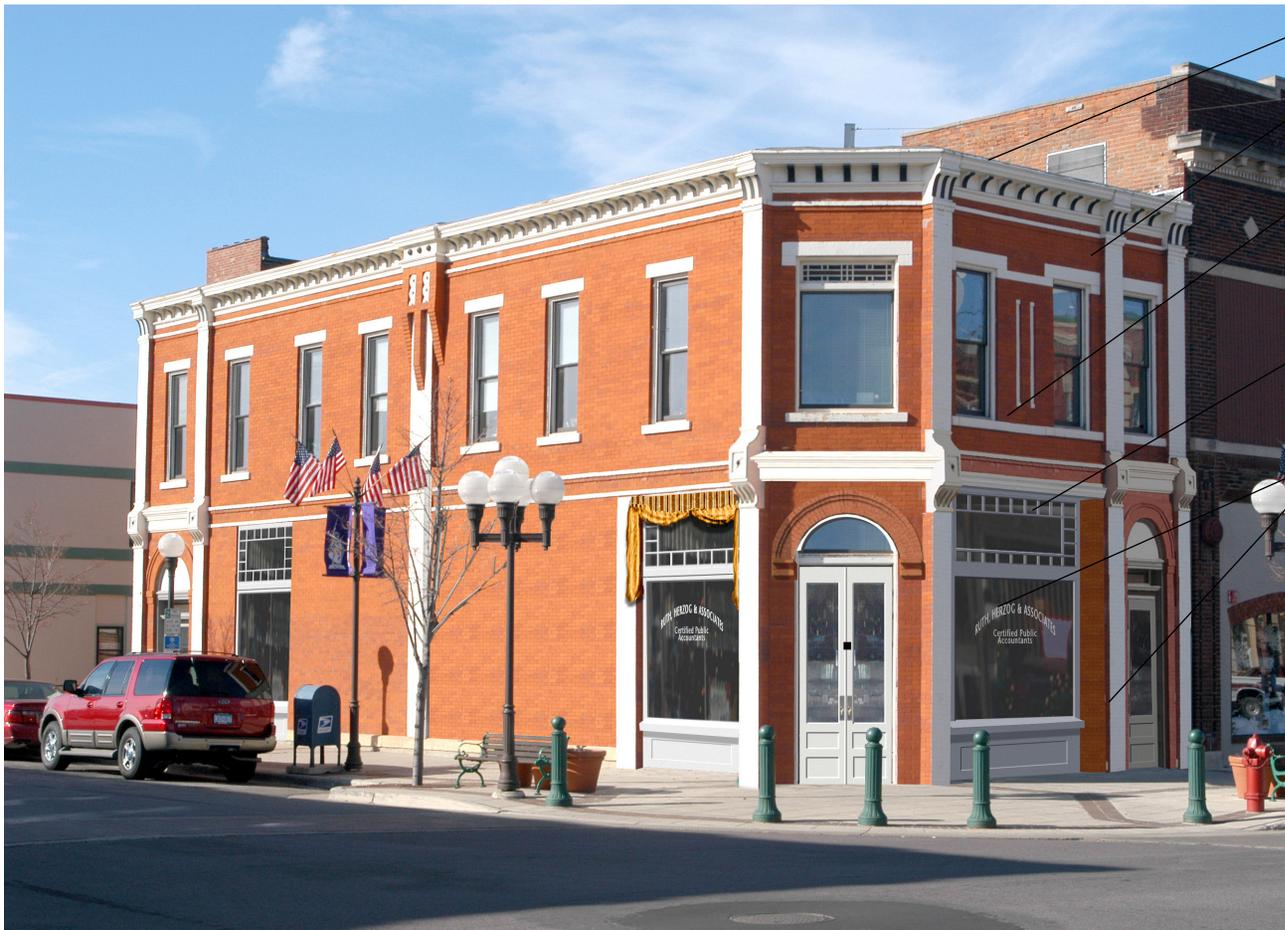
POTENTIAL RENOVATION

Inspect roofing and flashing.

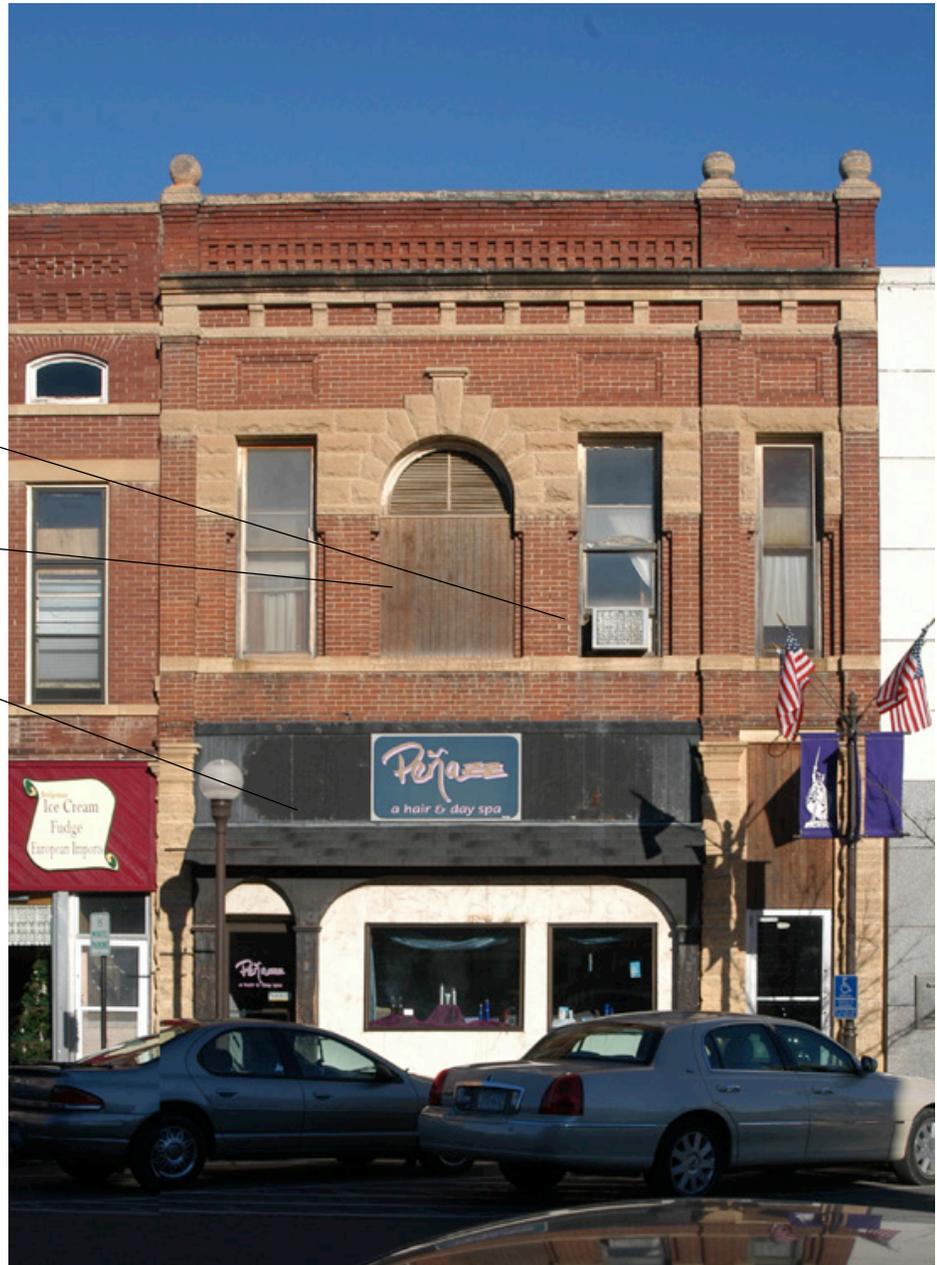
The first story has had a number of renovations that have hidden its original simple design

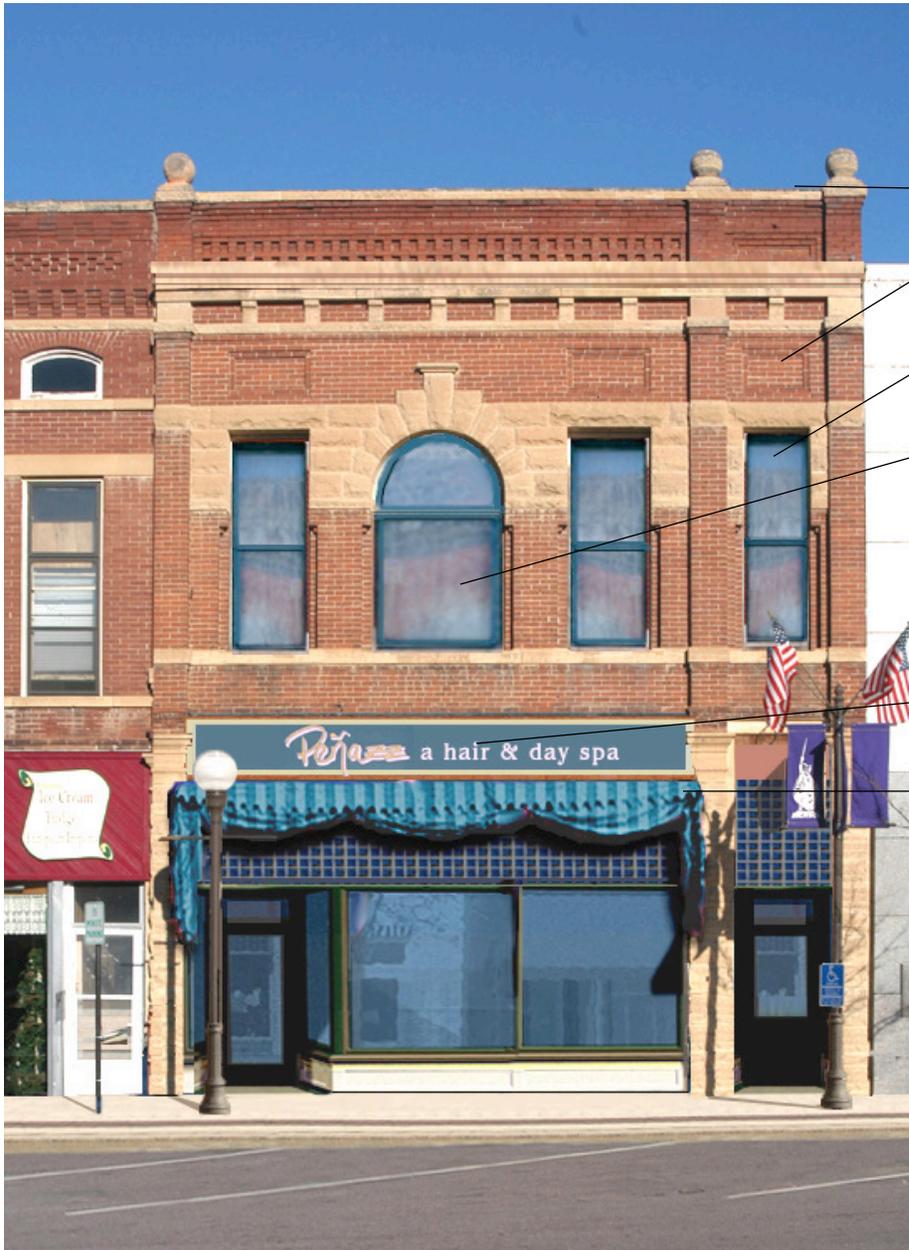
POTENTIAL RENOVATION

Inspect roofing and flashing

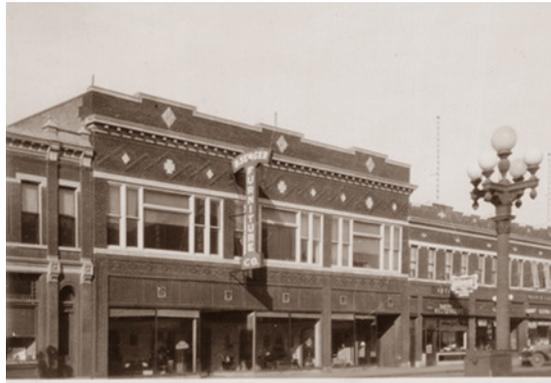
203 North Minnesota Street Buenger Furniture Company

Built in 1920, this once elegant structure has had all of its original bays infilled with inappropriate materials and treatments.

Vertical wood panels fill the three window bays on the second story giving the building a blank look.

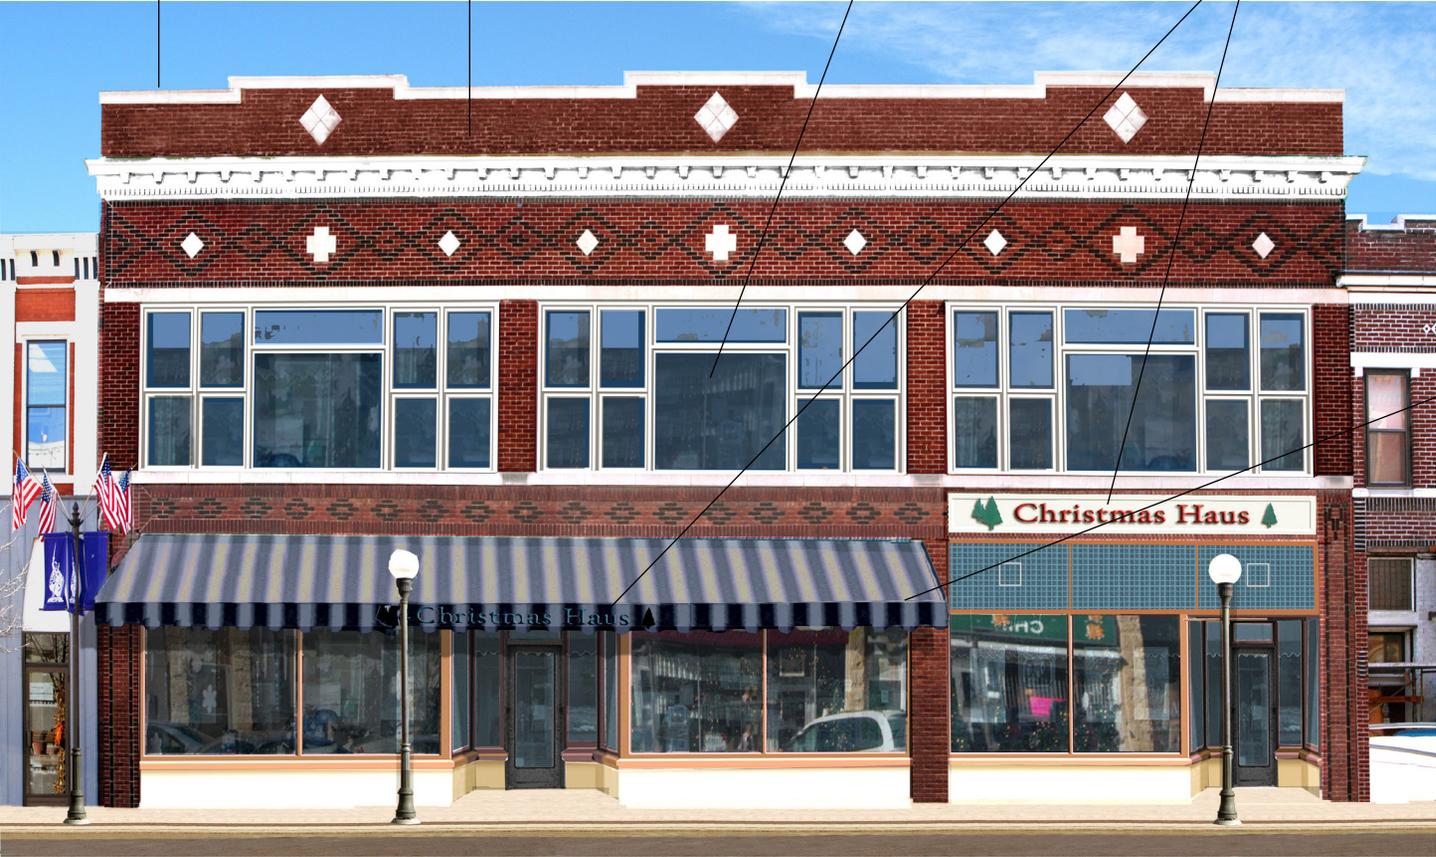
Place signage on a signboard—above the store front and below the upper-level windows. Additional signage may appear on the awning valance.

Hang a canvas, retractable awning over the display windows.

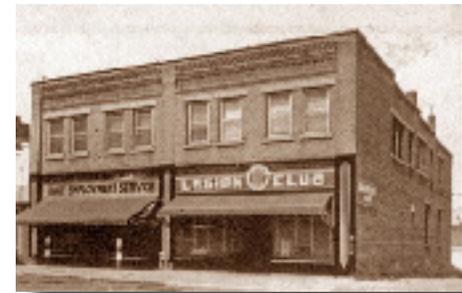
This two-story brick structure was built in 1911. Numerous businesses have resided in the two bayed building. Most recently the American Legion has been located here.

While the upper story retains its original fenestration and design elements, the bay-defining piers have been inappropriately painted white. The first story bay storefronts have been totally obscured by a monolithic treatment in modern sheathing materials.

Remove air-conditioner from main facade

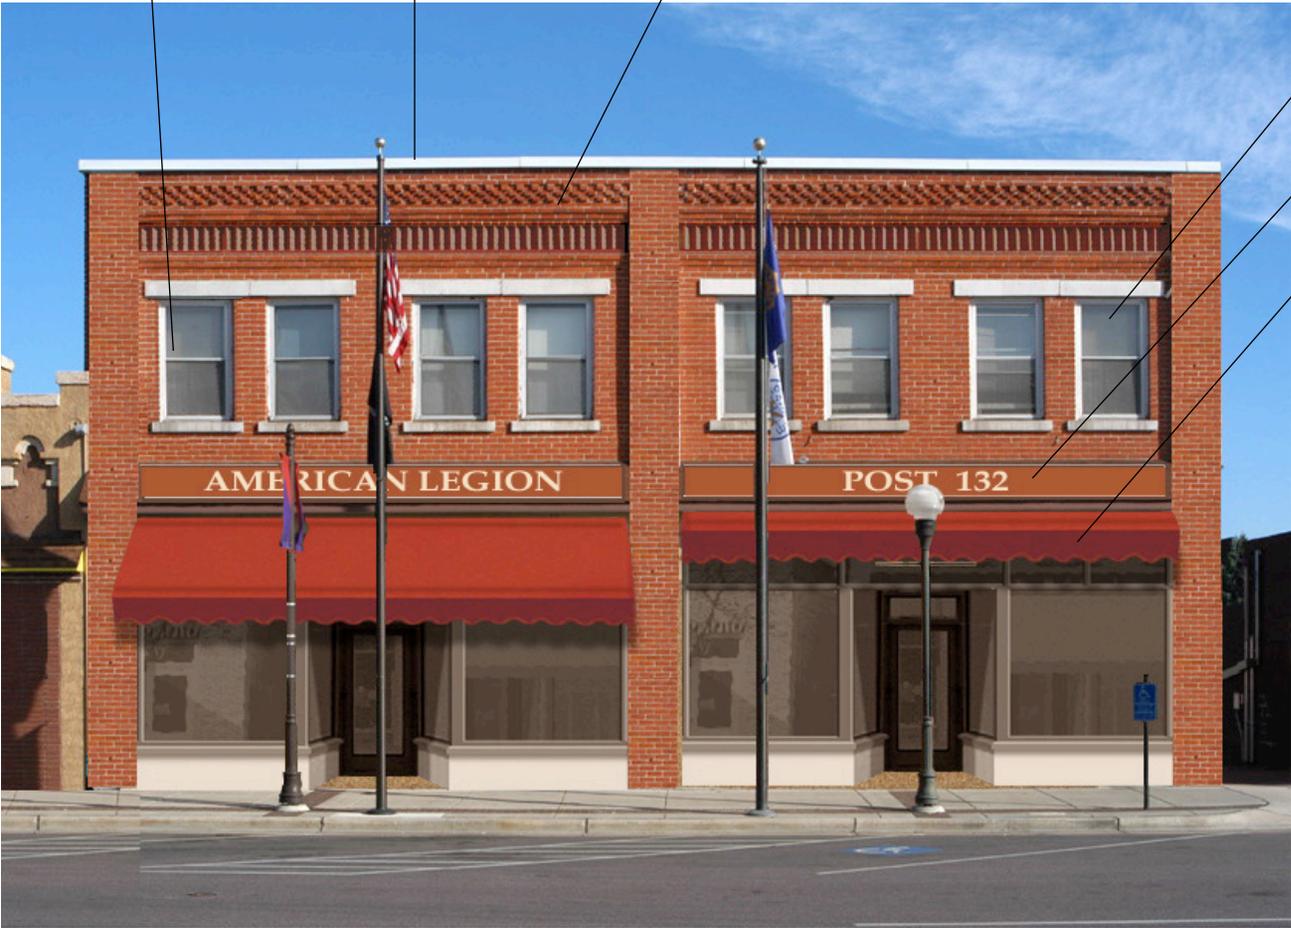
POTENTIAL RENOVATION

Repoint, repair and clean brick as necessary and return piers to their original brick color

Repair existing windows or replace with insulated double-hung windows

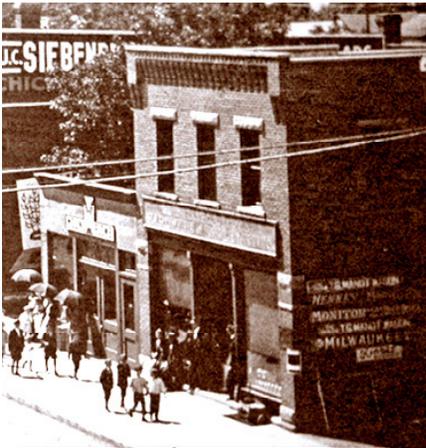
The two-story portion of this structure was built in 1902. Ten years later the Engelberts built a one-story addition.

The first story bay storefronts have been totally obscured by vertical wood siding

Inspect roofing and flashing *Repoint, repair and clean brick as necessary*

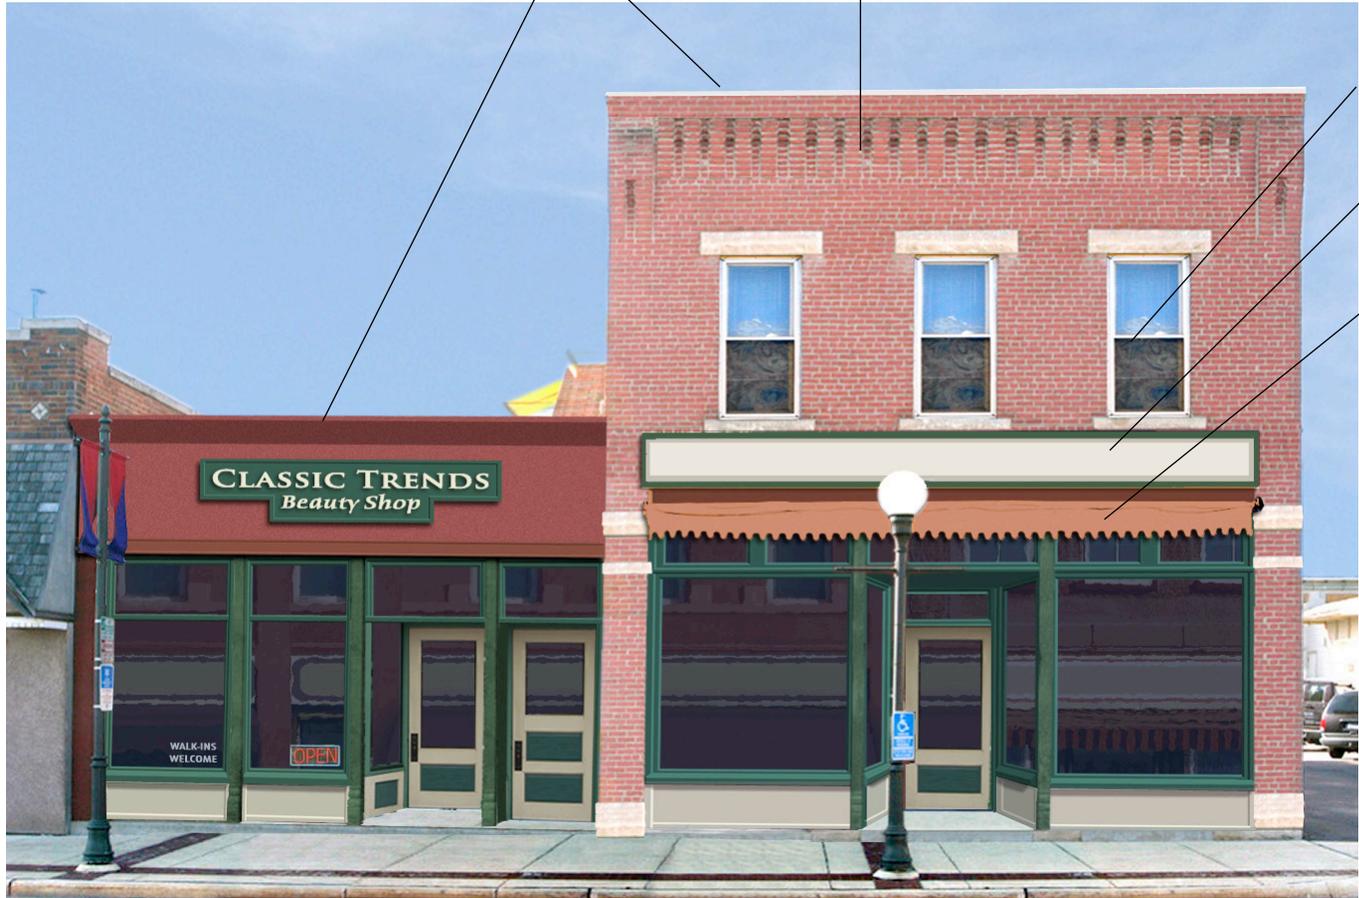
POTENTIAL RENOVATION

Repair existing windows or replace with insulated double-hung windows

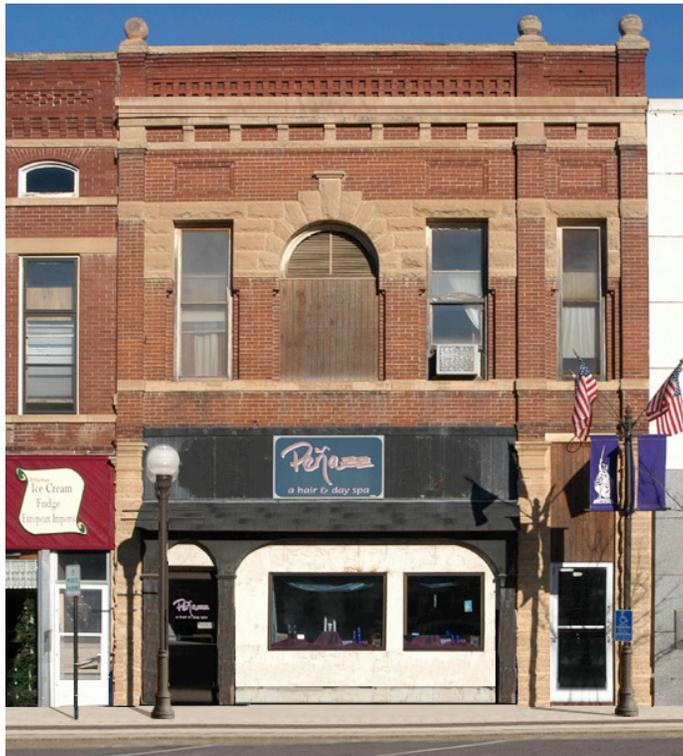
The storefront windows have been downsized and the doors do not match.

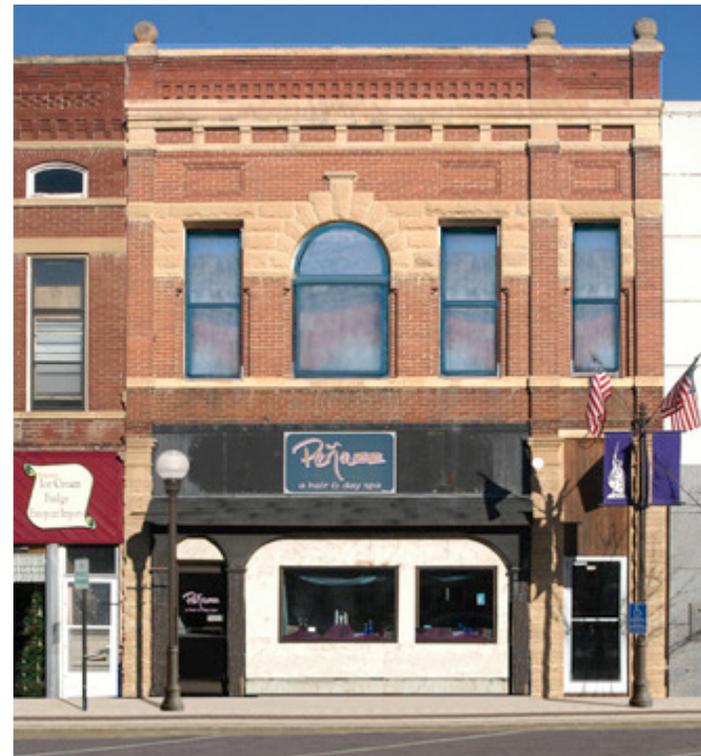
Phase 1

Repair and repoint the brick as necessary.

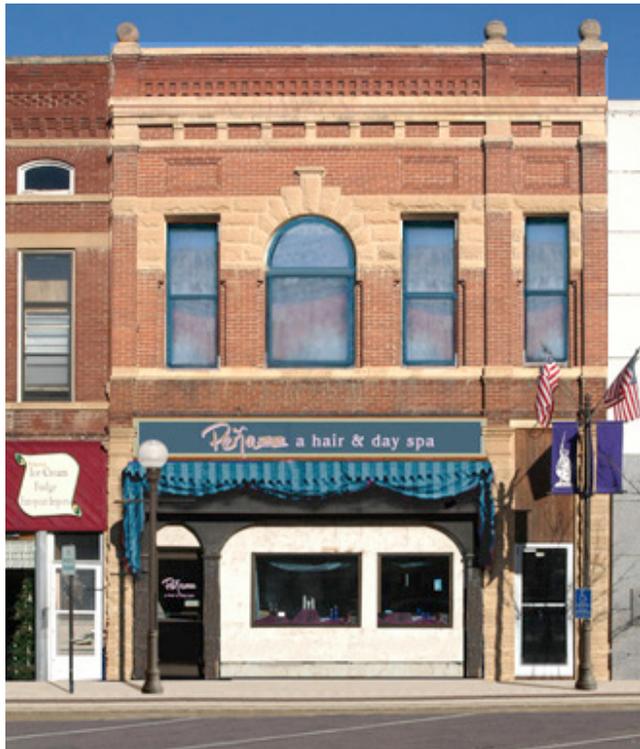
Phase 2

Apply appropriate signage on a flush signboard above the storefront.
Hang a retractable canvas awning over the storefront bay.

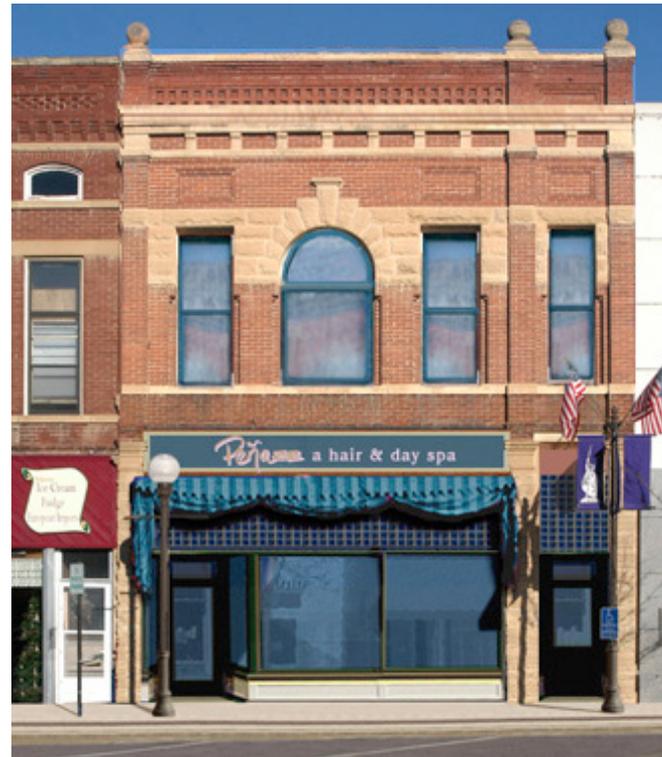
Phase 3

Rebuild storefronts as originally designed with large display windows with transom above and a bulkhead below.
Also, replace the side entry bay with an appropriate, complementary door with transom.

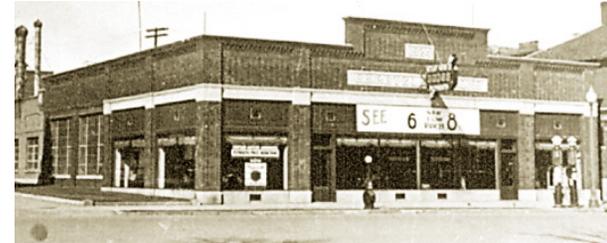
HISTORIC PHOTOGRAPH

Built in 1924, this one-story brick commercial building was constructed with large display windows spanning the Center Street facade. The property housed the Retzlaff Motor Company, an early Dodge automotive dealership in New Ulm. Through time this one-story early 20th-century building retained its original brick facade.

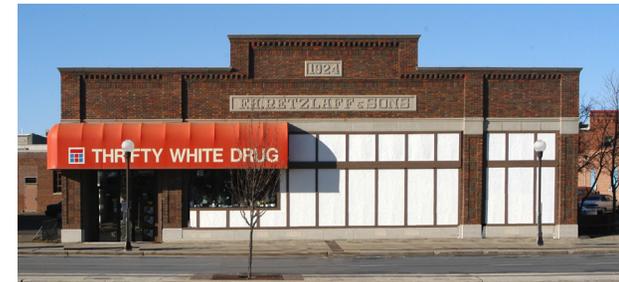
EXISTING CONDITION (2006)

Note the inappropriate "waterfall" awning extends across part of the western portion of the main facade and the window and transom openings are infilled with modern materials and treatment.

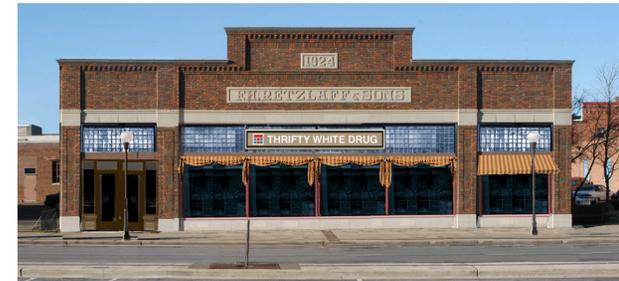
TODAY

Working from the historic photograph the renovation included the placement of the entry openings to their original location at the outer edges of the main, central bay of the commercial storefront.

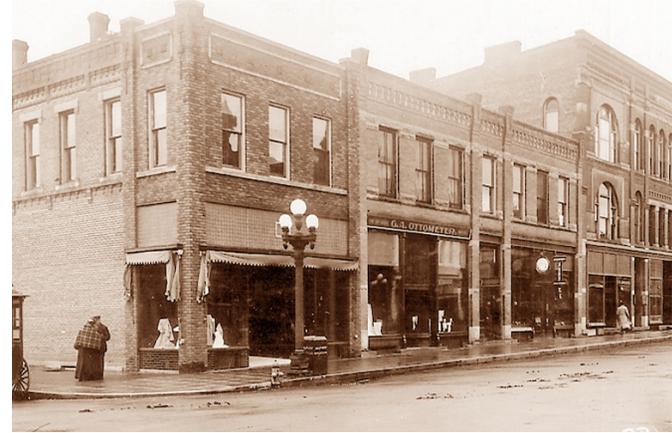
HISTORIC PHOTOGRAPH

Built in 1886, this two-story brick structure building retained its upper-story architectural integrity over the years but displayed multiple modifications at the storefront level.

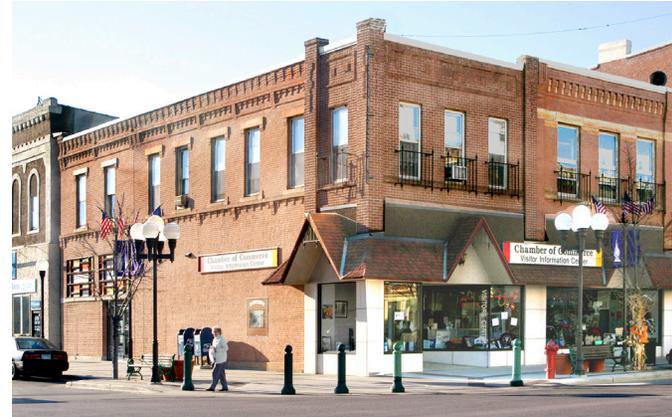
EXISTING CONDITION (2006)

Note that the gabled canopy roof over the entrance is inappropriate for a historic storefront and does not relate to any other architectural feature of the building. The transom openings were infilled with modern materials and treatments. Also, signage should relate to the individual buildings and not cross over the interface between two different buildings.

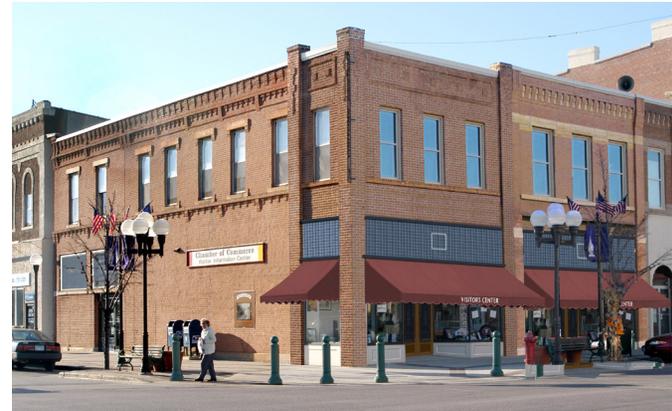
TODAY

Note that the display windows and new awnings are crowned with a band of transom windows, as originally designed.

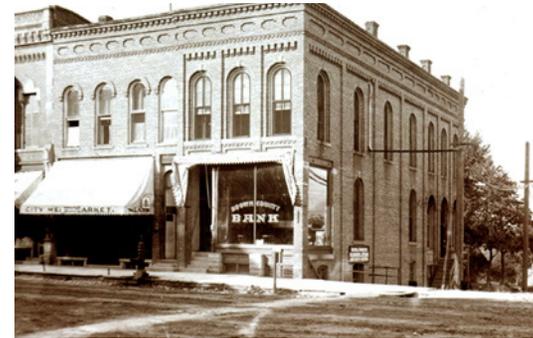
HISTORIC PHOTOGRAPH

Constructed in 1871, this prominent brick structure retained its upper-story arched window opening, and its brick exterior on both public elevations.

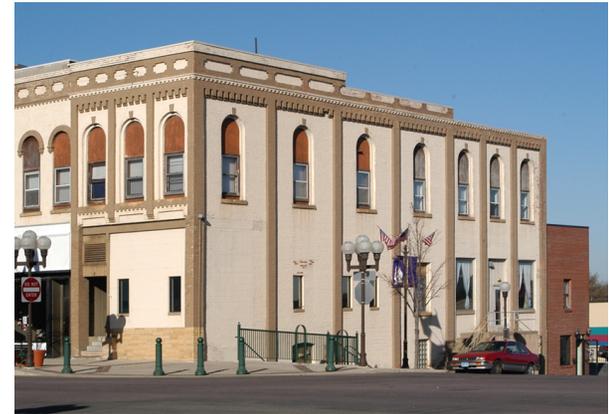
EXISTING CONDITION (2006)

The historic picture reveals that the prominent corner building had been modified over time with the storefront display windows and transom windows above on both the Center and North Minnesota elevations infilled with modern materials. Inappropriate undersized, residential-scale windows had been installed on the North Minnesota Street elevation.

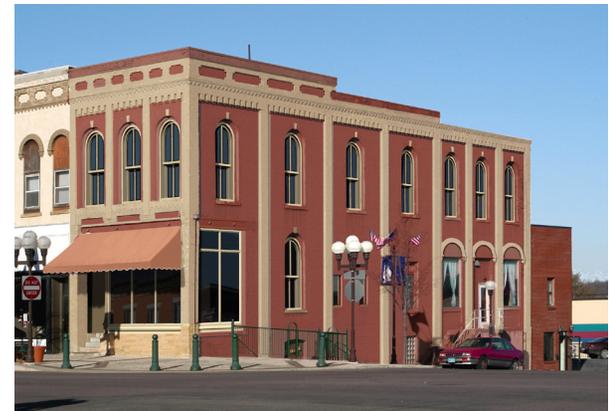
TODAY *Note that the original design including display and transom windows have been re-introduced to both the front and side storefront elevations and a new canvas awnings crowns the main storefront display bay.*
